PROJECT:
DUNNSTOWN RECREATION RESERVE
2855 OLD MELBOURNE ROAD,
DUNNSTOWN VIC 3352

DATE: 17.10.2024

DRAWING: SITE ANALYSIS

CLIENT: MOORABOOL SHIRE COUNCIL

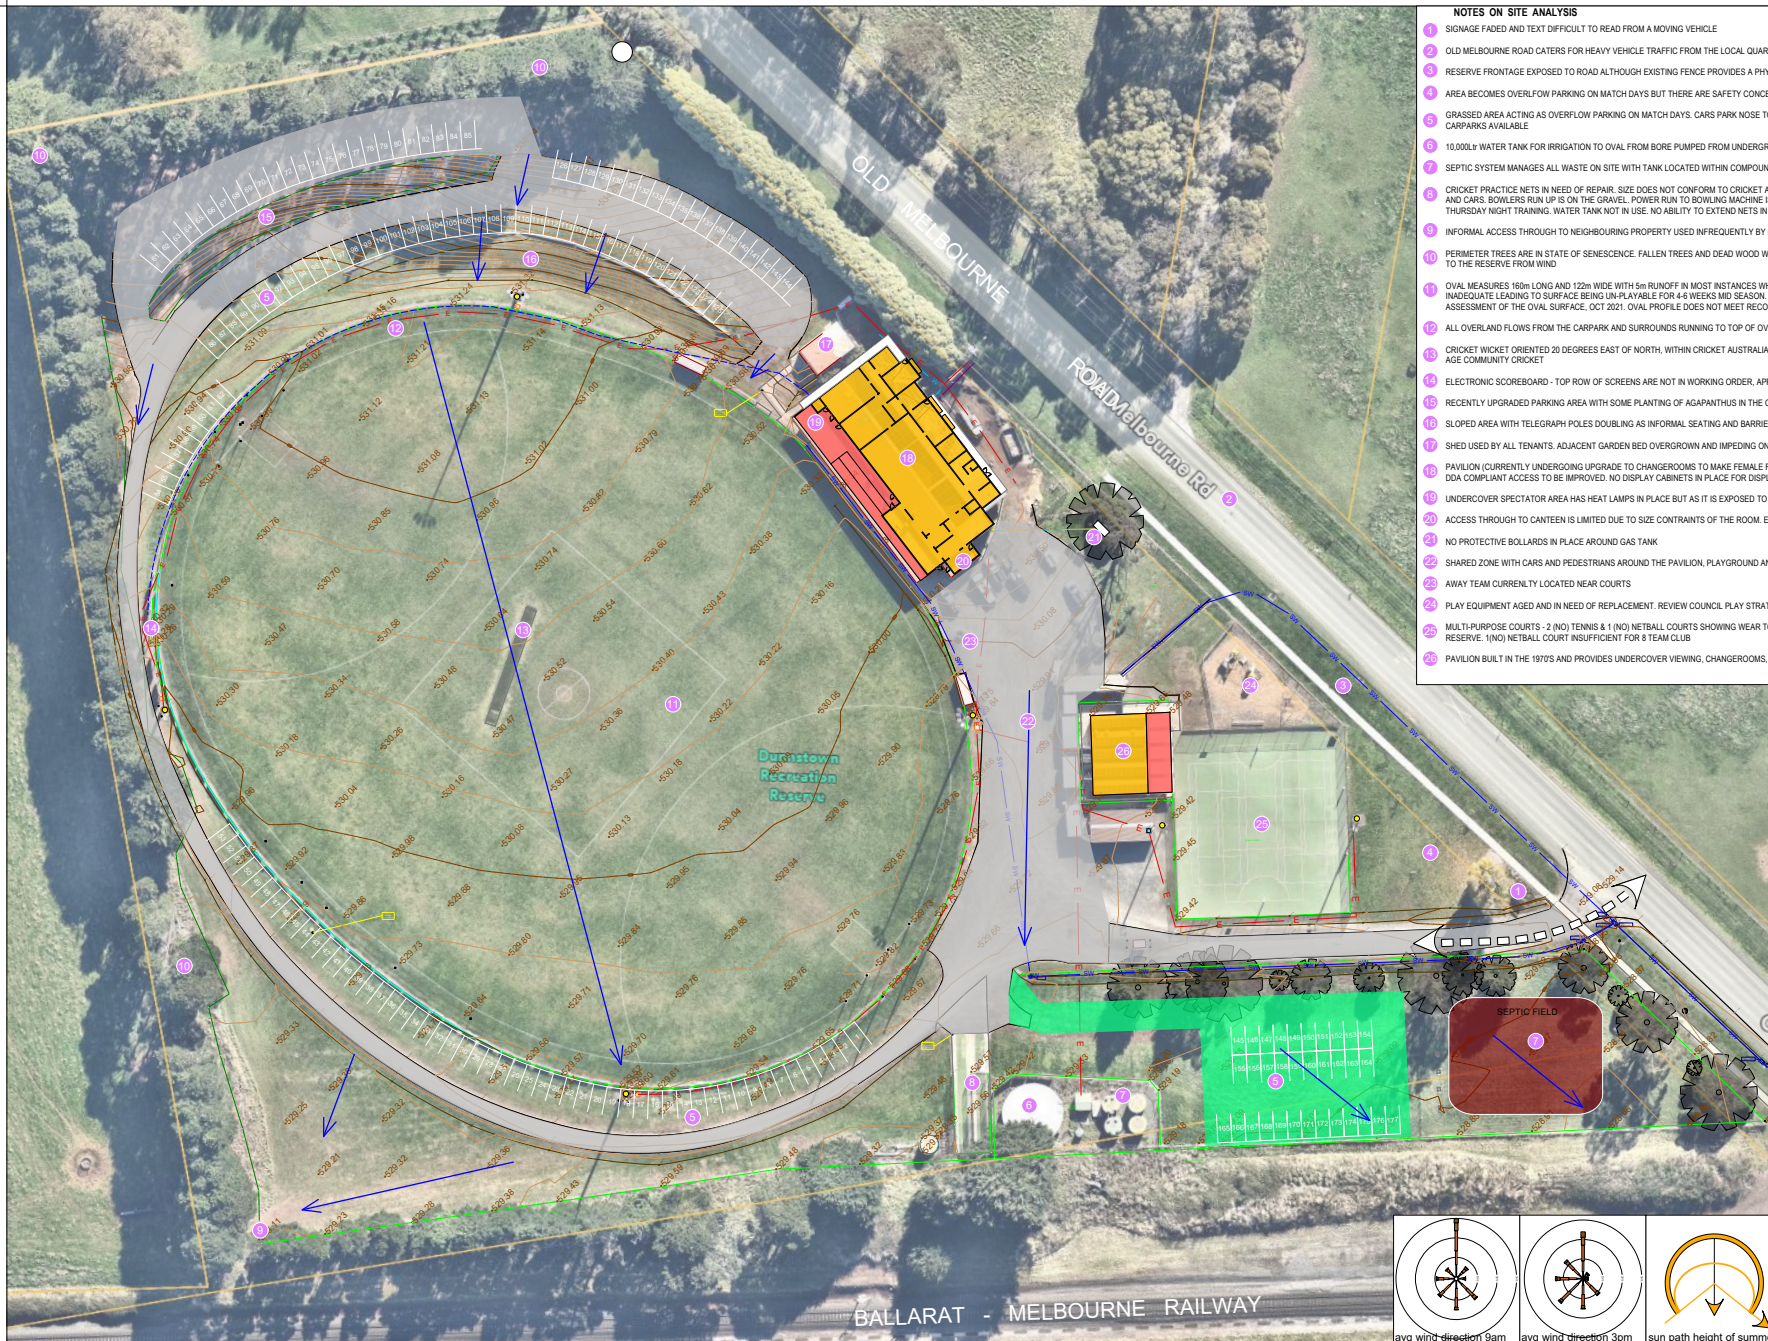
- ### NOTES ON SITE ANALYSIS
- SIGNAGE FADED AND TEXT DIFFICULT TO READ FROM A MOVING VEHICLE
 - OLD MELBOURNE ROAD CATERERS FOR HEAVY VEHICLE TRAFFIC FROM THE LOCAL QUARRY. SPEED LIMIT NOW 60km/h BUT SPEEDING TRUCKS PRESENT A SAFETY ISSUE.

- RESERVE FRONTAGE EXPOSED TO ROAD ALTHOUGH EXISTING FENCE PROVIDES A PHYSICAL BARRIER
 - AREA BECOMES OVERFLOW PARKING ON MATCH DAYS BUT THERE ARE SAFETY CONCERNS WITH PARKING HERE

- GRASSED AREA ACTING AS OVERFLOW PARKING ON MATCH DAYS. CARS PARK NOSE TO FENCE ON MATCH DAYS AROUND THE OVAL PERIMETER. APPROX 177 ON SITE CARPARKS AVAILABLE

- 10,000L WATER TANK FOR IRRIGATION TO OVAL FROM BORE PUMPED FROM UNDERGROUND SPRING
 - SEPTIC SYSTEM MANAGES ALL WASTE ON SITE WITH TANK LOCATED WITHIN COMPOUND AND SEPTIC FIELD TO THE EAST

- CRICKET PRACTICE NETS IN NEED OF REPAIR. SIZE DOES NOT CONFORM TO CRICKET AUSTRALIA FACILITY GUIDELINES. ORIENTATION CAUSES CONFLICT BETWEEN BALLS AND CARS. BOWLERS RUN UP IS ON THE GRAVEL. POWER RUN TO BOWLING MACHINE IS 30m. PINE TREES IMPACT NETS AT THE REAR. ADDITIONAL NET REQUIRED FOR THURSDAY NIGHT TRAINING. WATER TANK NOT IN USE. NO ABILITY TO EXTEND NETS IN CURRENT LOCATION WITHOUT IMPACTING VEHICLE ACCESS AROUND OVAL

- INFORMAL ACCESS THROUGH TO NEIGHBOURING PROPERTY USED INFREQUENTLY BY PROPERTY OWNER
 - PERIMETER TREES ARE IN STATE OF SENESCENCE. FALLEN TREES AND DEAD WOOD WERE VISIBLE ON THE DAY OF INSPECTION. TREES PROVIDE VALUABLE PROTECTION TO THE RESERVE FROM WIND

- OVAL MEASURES 160m LONG AND 122m WIDE WITH 5m RUNOFF IN MOST INSTANCES WHICH IS LESS THAN AFL PREFERRED SENIOR SIZE 165 x 135m. DRAINAGE INADEQUATE LEADING TO SURFACE BEING UN-PLAYABLE FOR 4-6 WEEKS MID SEASON. FENCING AGED. THE SPORTS LIGHTING HAS BEEN UPGRADED. REFER STR1 ASSESSMENT OF THE OVAL SURFACE, OCT 2021. OVAL PROFILE DOES NOT MEET RECOMMENDED PROFILE

- ALL OVERLAND FLOWS FROM THE CARPARK AND SURROUNDS RUNNING TO TOP OF OVAL, CONTRIBUTING TO WATER LOGGING
 - CRICKET WICKET ORIENTED 20 DEGREES EAST OF NORTH, WITHIN CRICKET AUSTRALIA RECOMMENDED ORIENTATION. PLAYING FIELD APPROX 96m RADIUS TO SUIT OPEN AGE COMMUNITY CRICKET

- ELECTRONIC SCOREBOARD - TOP ROW OF SCREENS ARE NOT IN WORKING ORDER, APPROX 10 YRS OLD. SIZE SUITABLE
 - RECENTLY UPGRADED PARKING AREA WITH SOME PLANTING OF AGAPANTHUS IN THE CENTRAL GARDEN BED. ROCKS ACTING AS BARRIER TO CARS

- SLOPED AREA WITH TELEGRAPH POLES DOUBLING AS INFORMAL SEATING AND BARRIER TO CARS. NO FORMAL SEATING.
 - SHED USED BY ALL TENANTS. ADJACENT GARDEN BED OVERGROWN AND IMPEDING ON PATHWAY ACCESS.

- PAVILION CURRENTLY UNDERGOING UPGRADE TO CHANGEROOMS TO MAKE FEMALE FRIENDLY, WITH UNIPRES ROOM, GYM, FIRST AID AND ADDITIONAL STORAGE. DDA COMPLIANT ACCESS TO BE IMPROVED. NO DISPLAY CABINETS IN PLACE FOR DISPLAY OF TROPHIES AND MEMORABILIA. CEILING TILES IMPACTED BY MOISTURE

- UNDERCOVER SPECTATOR AREA HAS HEAT LAMPS IN PLACE BUT AS IT IS EXPOSED TO THE WIND, THE HEAT ESCAPES. IMPROVE DDA ACCESS THROUGH TO PAVILION
 - ACCESS THROUGH TO CANTENNE IS LIMITED DUE TO SIZE CONSTRAINTS OF THE ROOM. EXPLORE DDA COMPLIANCE OF ACCESS DOORS

- NO PROTECTIVE BOLLARDS IN PLACE AROUND GAS TANK
 - SHARED ZONE WITH CARS AND PEDESTRIANS AROUND THE PAVILION, PLAYGROUND AND NETBALL COURTS A POTENTIAL SAFETY RISK

- AWAY TEAM CURRENTLY LOCATED NEAR COURTS
 - PLAY EQUIPMENT AGED AND IN NEED OF REPLACEMENT. REVIEW COUNCIL PLAY STRATEGY TO ASSESS HIERARCHY AND LEVEL OF FUNDING AVAILABLE FOR UPGRADE

- MULTI-PURPOSE COURTS - 2 (NO) TENNIS & 1 (NO) NETBALL COURTS SHOWING WEAR TO SURFACE. REFER 2MH COURT AUDIT REPORT. NO ACTIVE TENNIS CLUB AT RESERVE. 1 (NO) NETBALL COURT INSUFFICIENT FOR 8 TEAM CLUB

- PAVILION BUILT IN THE 1970S AND PROVIDES UNDERCOVER VIEWING, CHANGEROOMS, AND CLUBROOMS. AUDIT AGAINST EXISTING SPORTS FACILITY RECOMMENDATIONS
