## Werribee Vale Road S96A

### Geotechnical Assessment

1008283.2 R1 v2

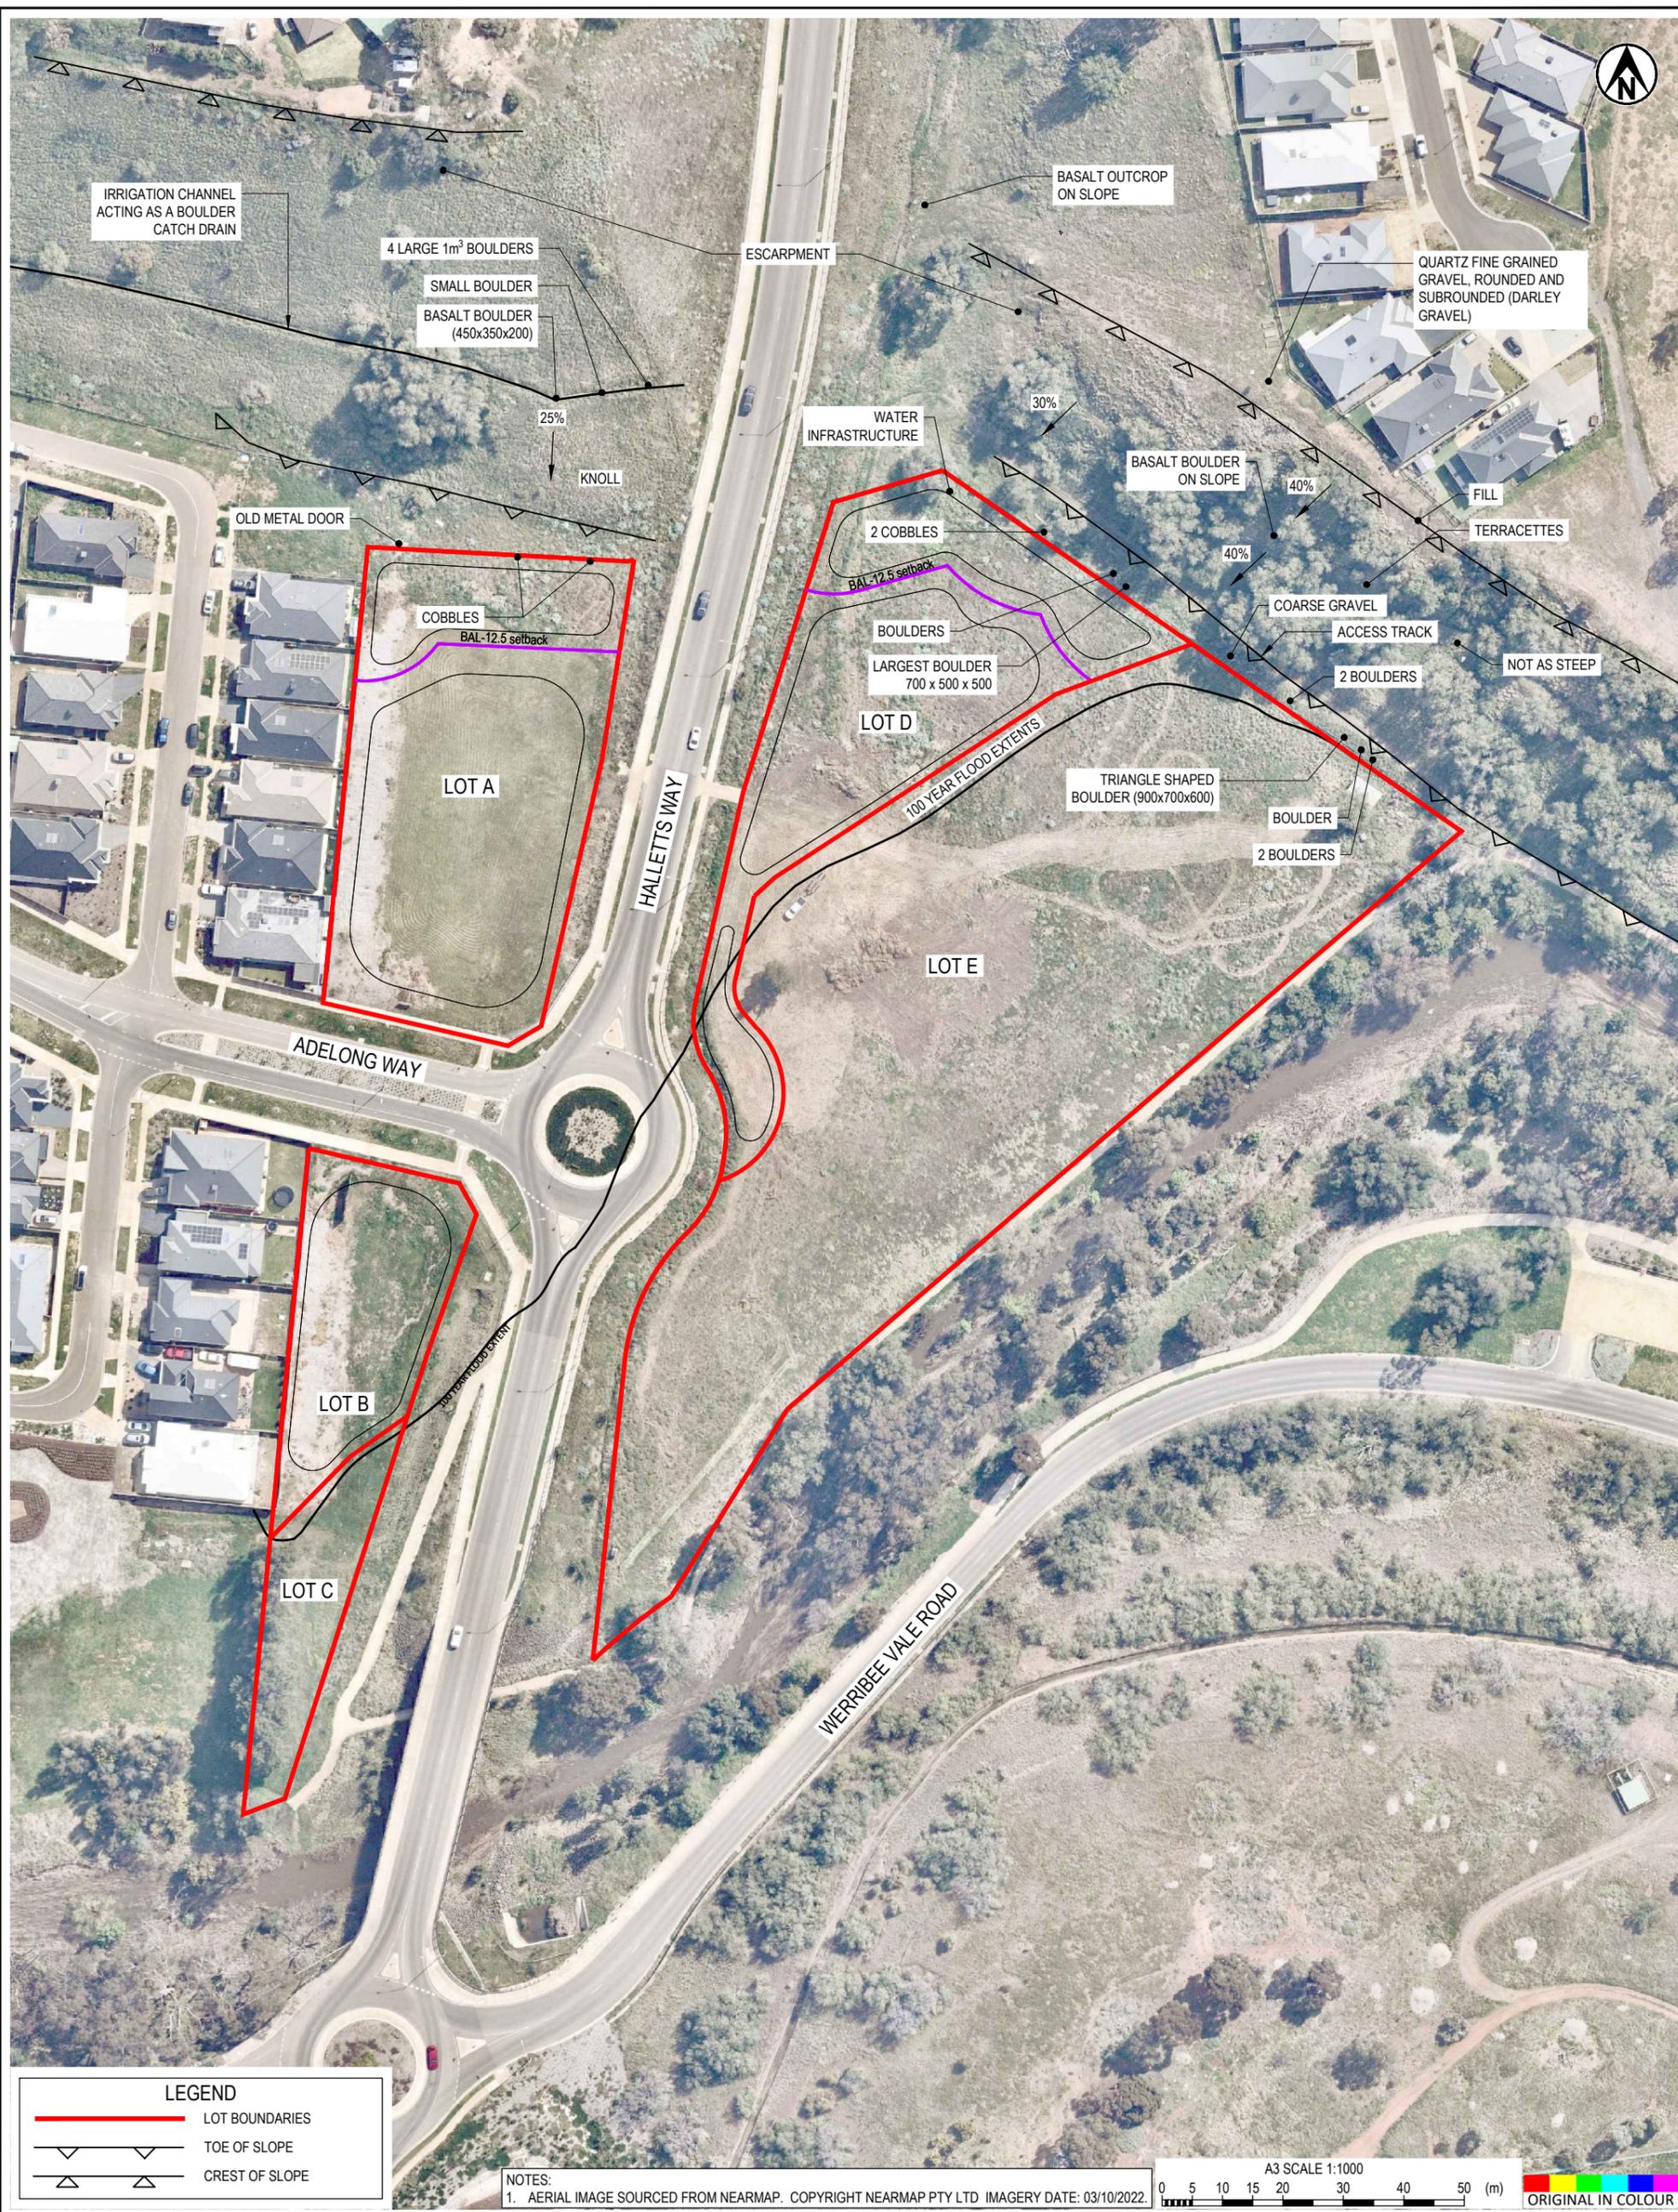
PROJECT No. 1008283.2000			CLIENT <b>PLENTI PROPERTY PTY LTD</b>		
DESIGNED	TSM	Dec.22	PROJECT <b>WERRIBEE VALE ROAD S96A</b>		
DRAWN	KMJA	Dec.22	TITLE <b>ESCARPMENT ASSESSMENT</b>		
CHECKED			<b>REVISION 1</b>		
APPROVED			SCALE (A3) 1:1250	FIG No. 1008283.2000-F01	REV 1

The site observations from the site walkover are noted in Figure 1. Selected site photographs are attached in Appendix A.

On the eastern side of Halletts Way a series of boulders were noted at the most eastern extent of the historic irrigation channel and at the toe of the slope (Figure 1). The largest of these boulders was approximately 1m<sup>3</sup> in size. No boulders were observed at the toe.

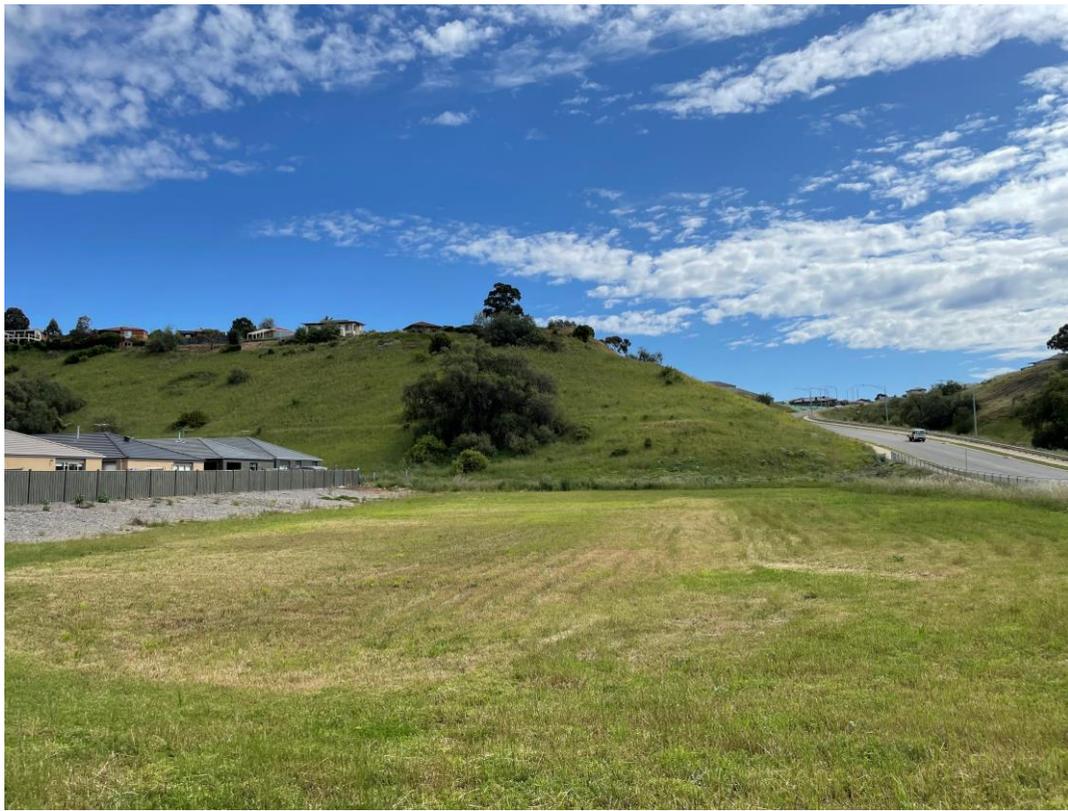
At the time of the site visit the escarpment west of Hallets Way was covered by long grass about a metre high and included a large tree near the middle of the slope. There is a historical irrigation channel on the slope, located about in the vertical centre of the slope. The overall slope angle is about 25°.

Escarpment west of Halletts Way (looking north)

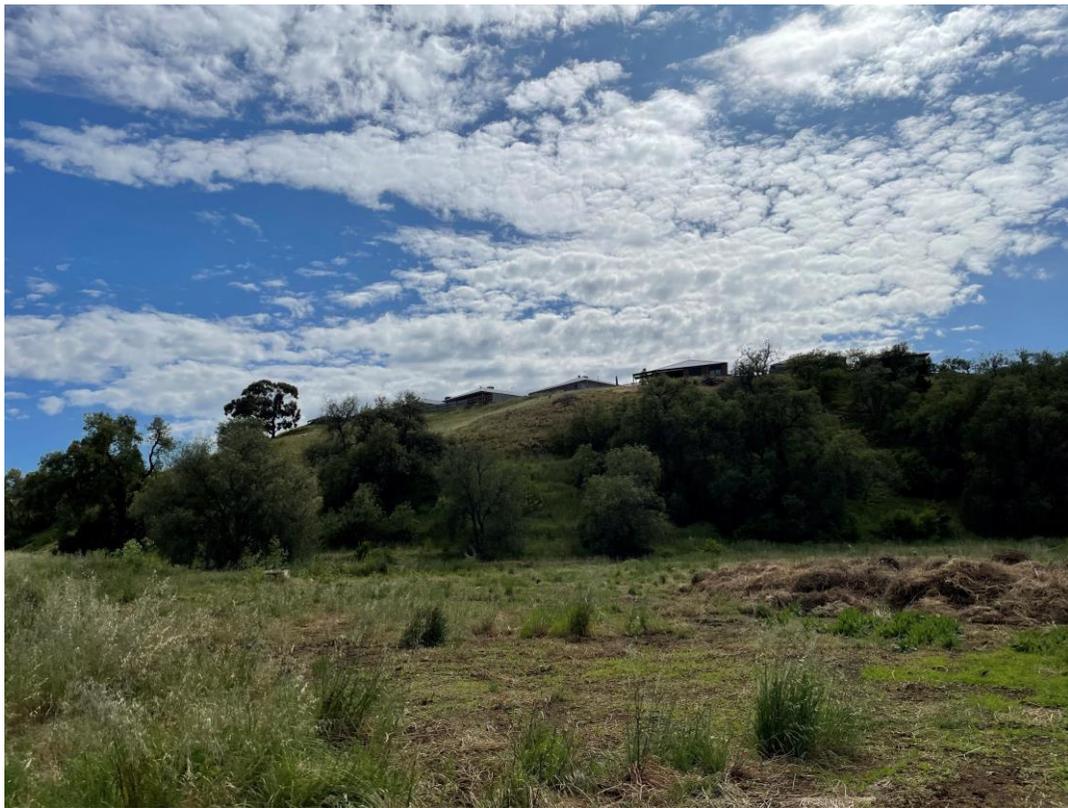
At the time of the site visit the escarpment east of Hallets Way was heavily treed with grass covering between the trees. Outcropping basalt was visible mid slope near Hallets way. The slope increased from about 30° near Hallets Way to about 40° in the mid part of the eastern area. An unsealed vehicle access track was at the toe of the slope.

Escarpment east of Halletts Way (looking north)

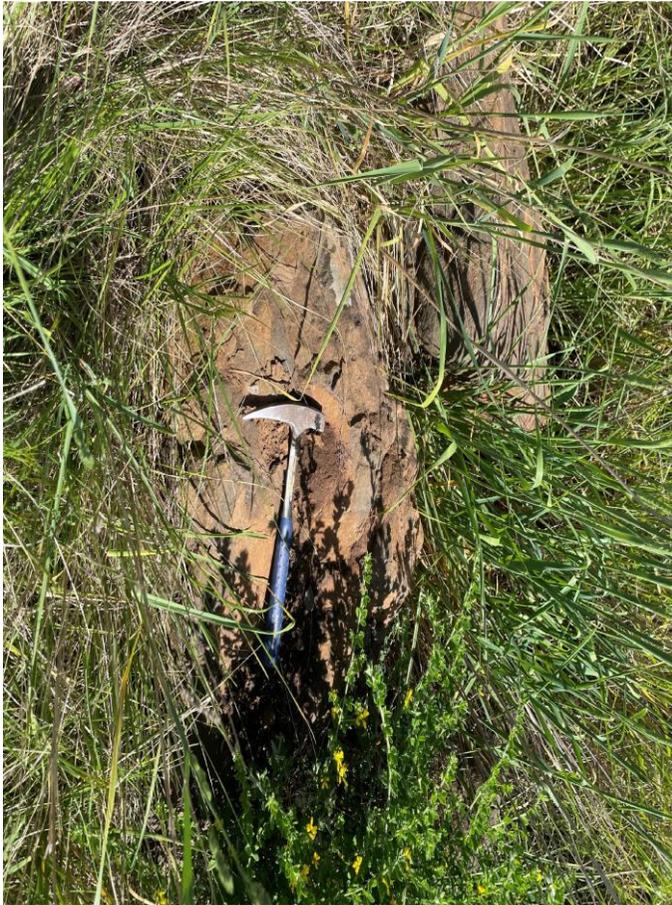
On the western side of Halletts Way about ten boulders and cobbles were noted on the escarpment side of an old wire fence near the toe of the escarpment. The boulders ranged up to an irregular shape with approximate maximum dimensions of 900mm x 700mm x 600mm. Terracettes were observed on the most eastern part of the escarpment.

The irrigation channel is acting to catch some boulders that are falling down the escarpment and thus is playing an important role in reducing the risk of boulder fall on the site. In order to improve the efficacy of the irrigation channels to catch boulder falls we recommend that they be cleaned out of boulders and other debris, prior to the construction of the rock fall barrier fence. We note that access to the irrigation channel with plant and equipment will be difficult and may make cleaning out of boulders and other debris impractical.

Boulders in irrigation channel west of Hallets Way

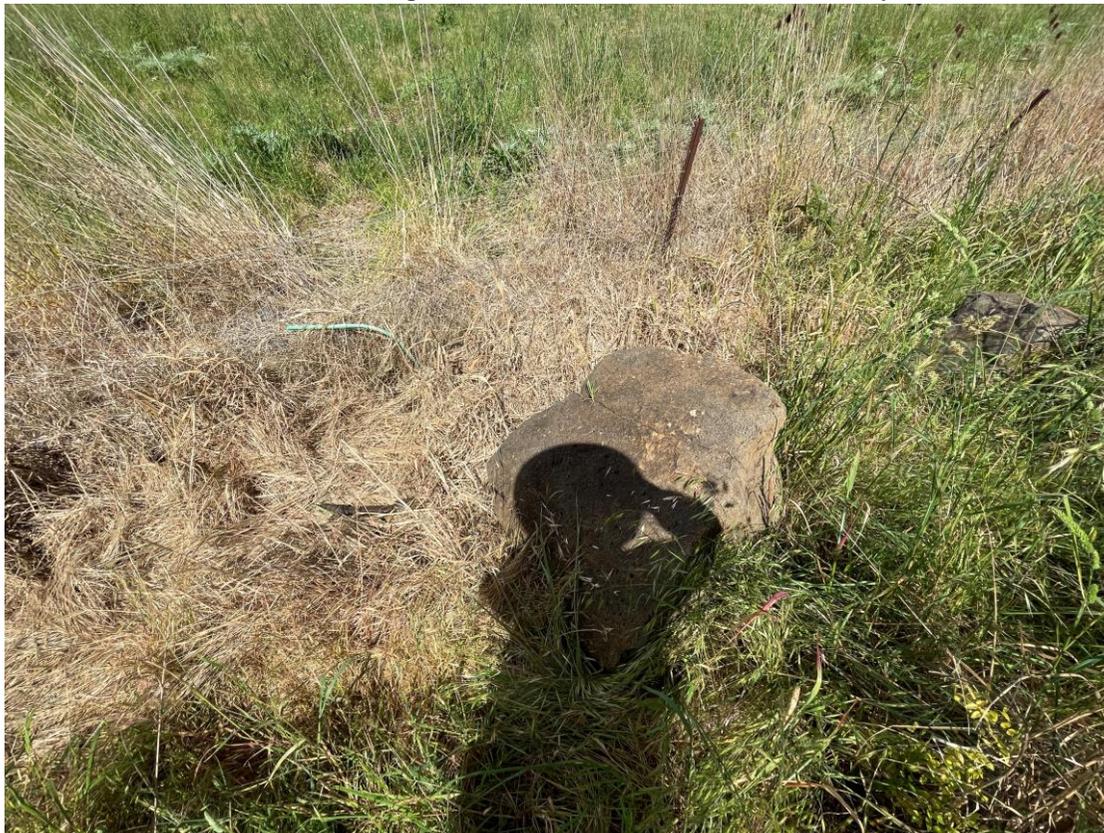
The boulders are considered likely to be mostly derived from residual basalt and/or basalt derived slope colluvium near the crest of the slope. Potential boulder release mechanisms include shrink/swell movements of soil due to wetting and drying and water flow during periods of higher rainfall. The slope vegetation may be assisting in retaining boulders in the soil and thus the risk of boulder fall may increase if the site were to experience fire or the vegetation on the escarpment were to be cleared for other reasons.

The considerable number of boulders observed during the site walkover indicates that boulder fall is a relatively common occurrence. Based on these observations we consider it likely that a rock catch fence, perhaps similar to that used in the neighbouring Underbank Development is likely to be required. The precise engineering requirements of the fence could be refined with a rock fall study and comparison to existing Australian road authority fence characteristics.

Boulders at base of escarpment east of Hallets Way (looking west)

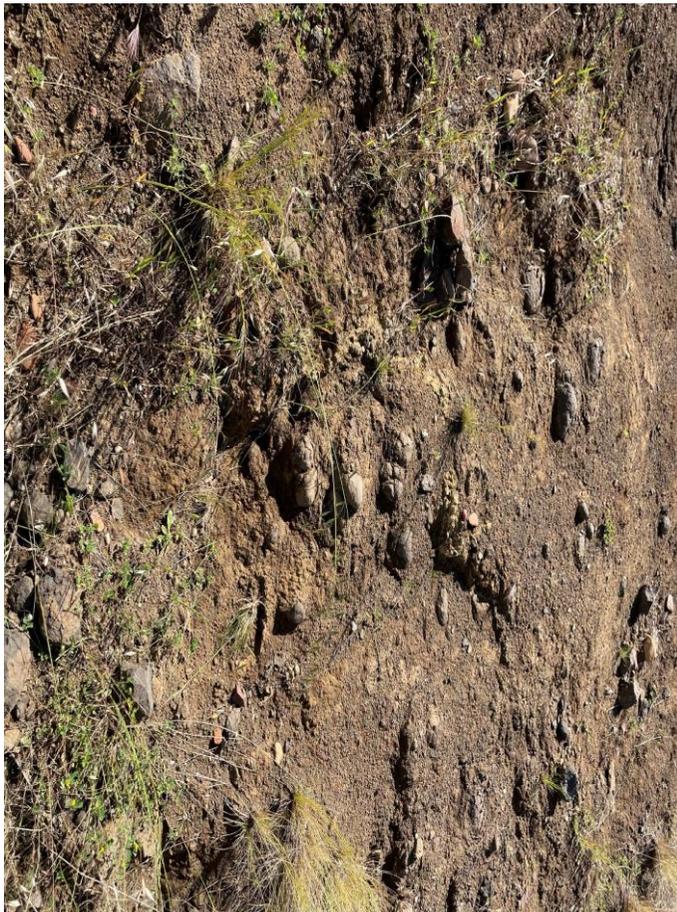
Exposed basalt on slope east of Hallets Way

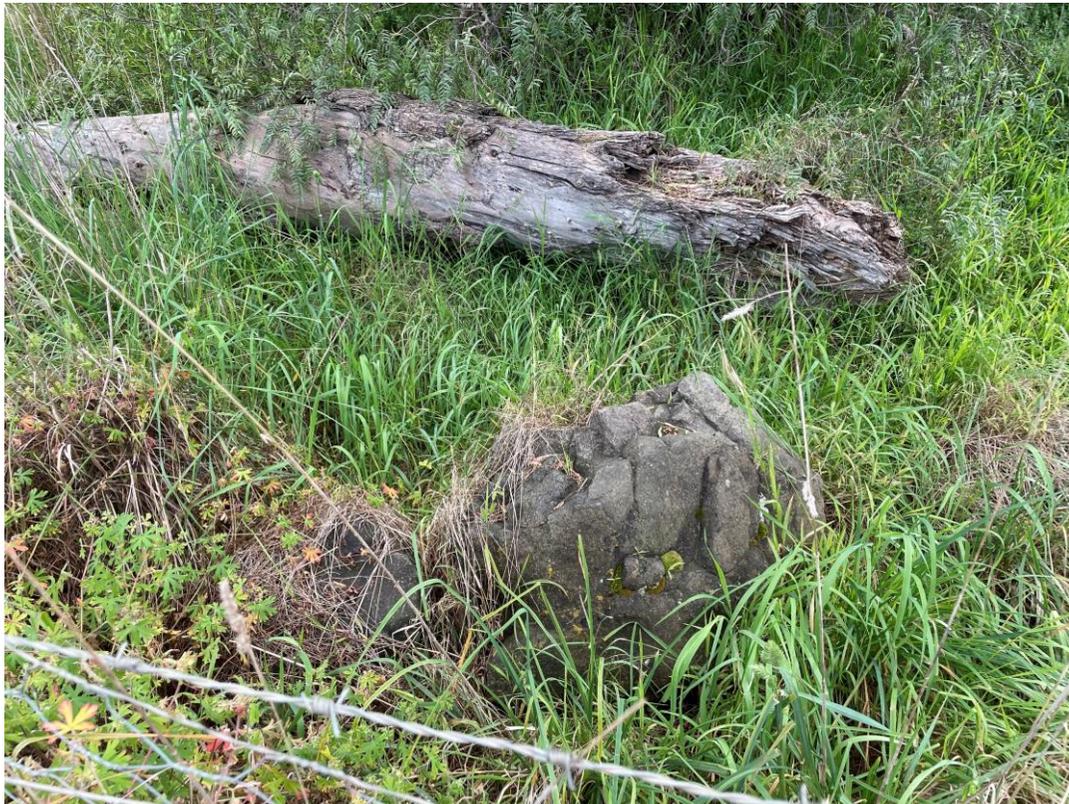
Boulder at toe of escarpment east of Hallets Way.
