**HOPETOUN PARK NORTH
RESIDENTIAL DEVELOPMENT**

INTERPRETIVE GEOTECHNICAL INVESTIGATION

REPORT NO V2211-1R2, MAY 2023

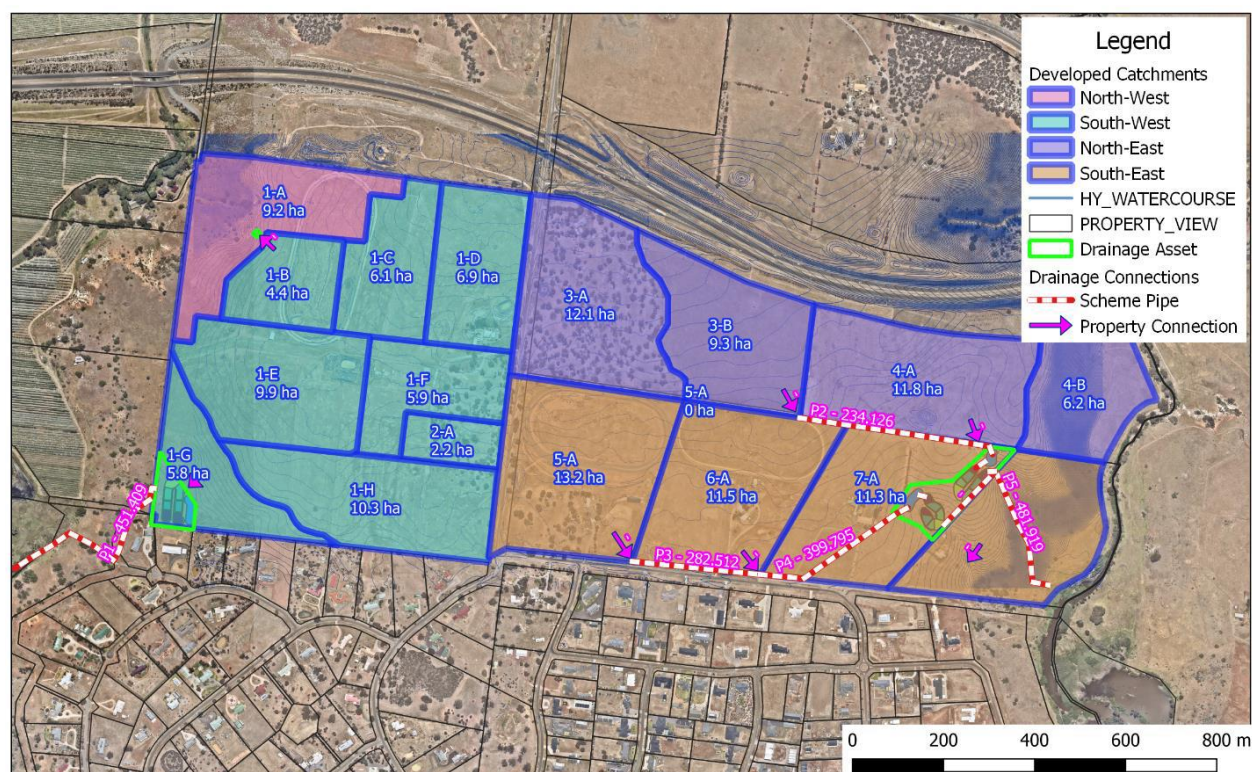
Image 2 – Proposed retarding basins and pipeline routes.

The location of the retarding basins and proposed pipeline routes down the escarpments is included in an image from Afflux Consulting, shown below in Image 2.

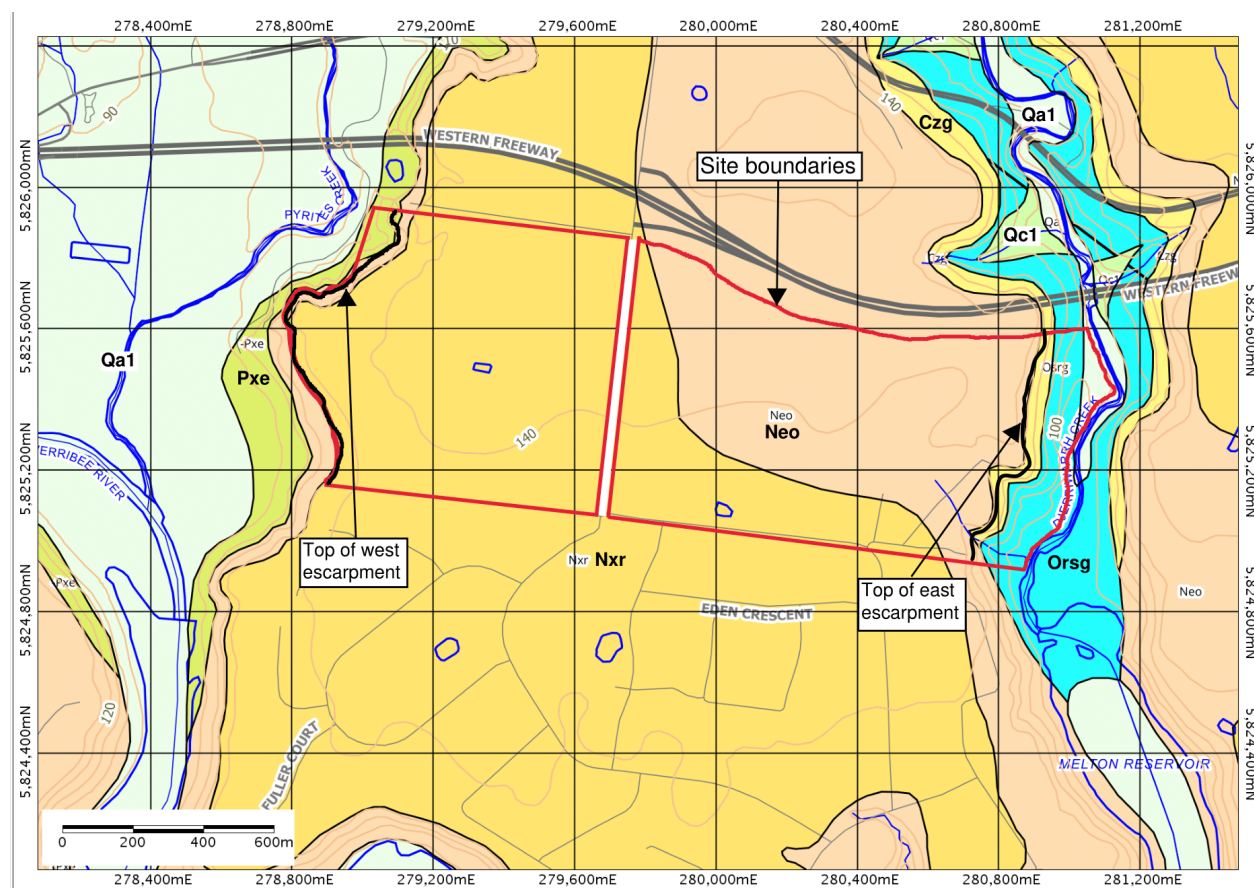
Image 3 – GeoVic3 database extract.

The GeoVic3 online, 1: 50,000 Series, state wide geological database, indicates the site surface geology is relatively complex across the site. The surface geology at the western and eastern escarpments is described below:

The database shows Neogene - Quaternary Period Newer Volcanics (Neo - basalt) on the approach to the slope. Going down the slope, Neogene – Quaternary Period conglomerate and sandstone (Czg – conglomerate, quartz sandstone and siltstone, conglomerate commonly ferruginised) is shown within the upper third, or so, of the slope, with much older Ordovician period Riddell Sandstone (Orsg – sandstone, black shale, black and grey siltstone) shown below.

The database shows the Neogene – Quaternary Period Darley Gravel (Nxr – gravel, sand and silt) on the approach to the slope. Going down the slope, the Newer Volcanics are shown within the top third, or so, of the slope, with Neogene Period Werribee Formation (-Pxe – sand, silt, clay, gravel) shown below this to the toe of the slope. Beyond the toe of the slope, Quaternary period alluvium associated with Pyrites Creek and the Werribee River is shown.

The database shows the Neogene – Quaternary Period Darley Gravel across much of the site, and Neogene – Quaternary period Newer Volcanics in the north and east of the site.

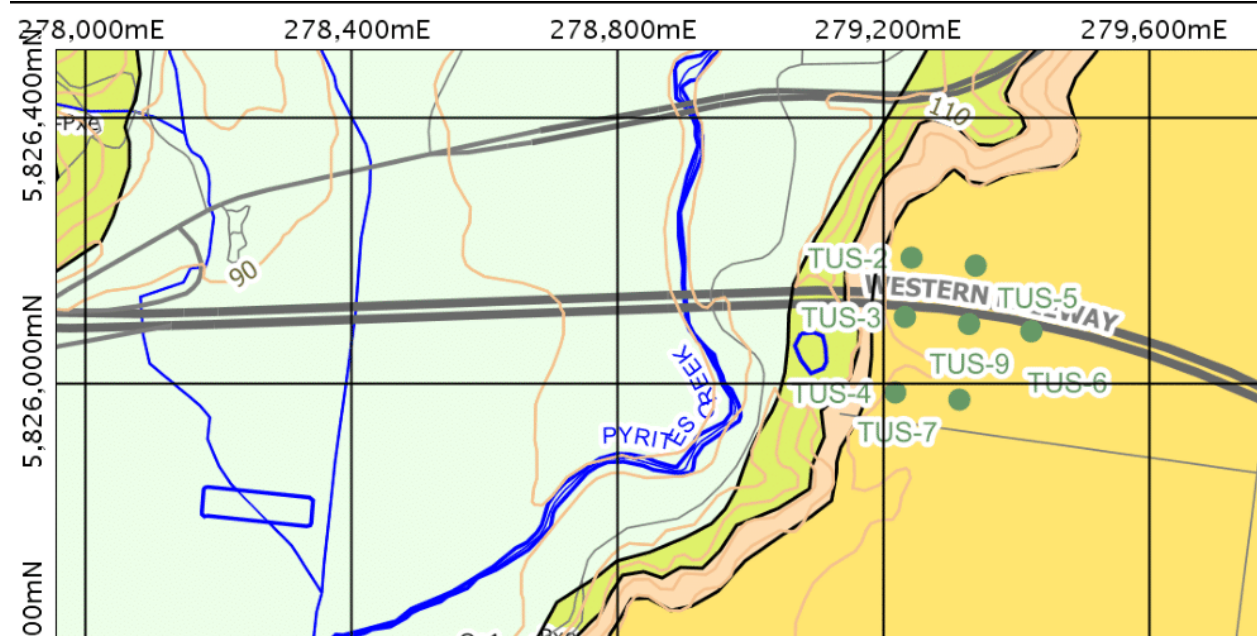
Image 4 – GeoVic3 extract showing historical boreholes.

Historical information available on Geovic3 show boreholes were drilled in 1983 between the north west corner of the site and the old Western Highway. Within the borehole information is a reference to a Soilmech Pty Ltd report titled “*Report on Investigation for Proposed Sand Pits at Bacchus Marsh*”, January 27, 1984. The report shows an existing sand pit located between the north west corner of the site and Cowans Road to the west of the site. The historical sand pit extents are well away from the site boundaries and will not affect the development.

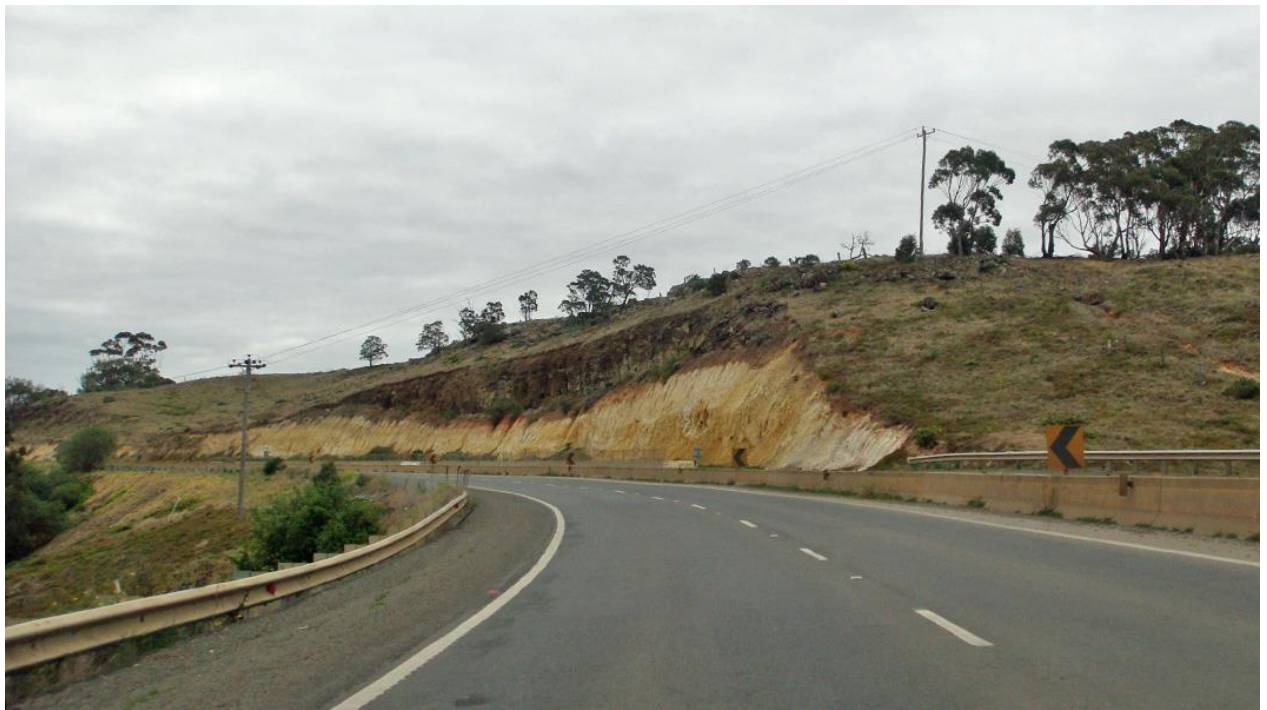
Image 6 – Anthony's Cutting, photo dated 2015. Image source: www.expressway.online

The cutting on the southern side of the Western Freeway reveals an important section into lava flows from Mount Bullengarook and Tertiary and Quaternary sediments. Flows of strongly jointed basalt outcrop at road level at the Melbourne end of the cutting and these are overlain by a 15 m thick deposit of cross-bedded non-marine Pleistocene sands and gravels. One hundred meters along the cutting (towards Bacchus Marsh), sandy clays, sands and gravels of the middle Tertiary Werribee Formation that underlies the Bullengarook lava flow are exposed at road level and the lavas are 10 to 15 m above road level. At the top of the Werribee Formation (beneath the lava flow) is a reddish zone in the sediments that is the weathering horizon and soil of the pre-basaltic land surface. It is therefore an example of paleosol. Several types of jointing and weathering occur in the volcanics.

This description matches the observed conditions on the western escarpment, except that the Darley Gravel (described as the non-marine Pleistocene sand and gravels by Rosengren) are much thinner on this site. It is considered likely that historical extraction of the Darley Gravel has reduced the thickness on site to negligible amounts. An image of Anthony's Cutting is shown below in Image 6.

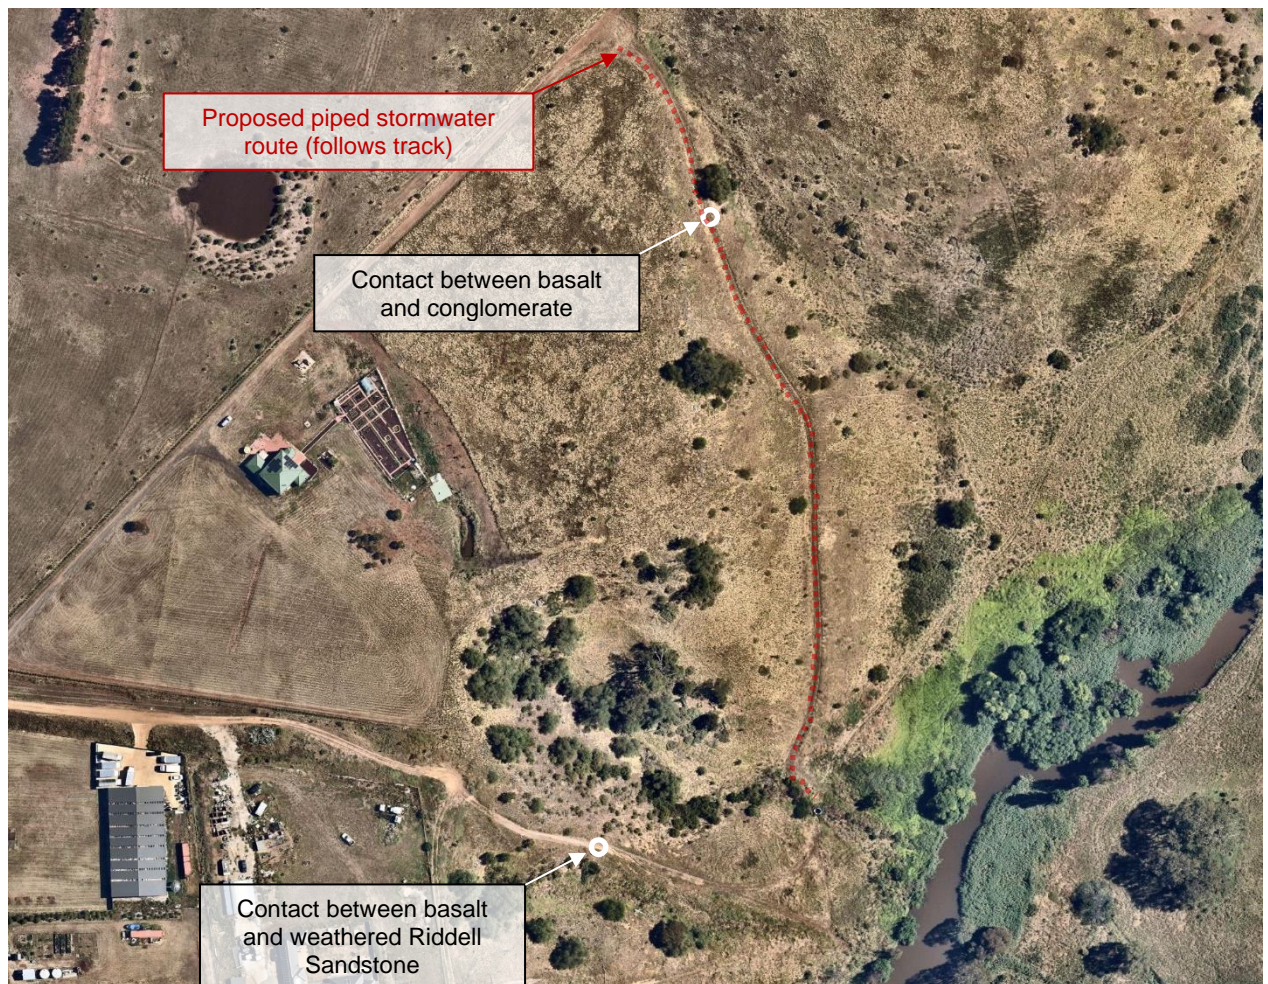
Image 9 – Marked up Nearmap image with geological contacts and proposed pipeline route.

Two potential geological contacts were noted on site. On the very steep path leading down from the eastern end of Hopetoun Park Road a contact between the Newer Volcanics basalt (Neo) and Ordovician Riddell Sandstone (Osr) was observed at an elevation of 108 m AHD. On the much less steep access track to the north of this, a contact between the basalt and likely Neogene – Quaternary Period ferruginised conglomerate (Czg) was observed at an elevation of 121 m AHD.

The proposed stormwater outfall location along the less steep access track is a good choice. The steeper access track would present significant construction challenges (it is difficult for a human to stand up, for example). The proposed track is still relatively steep and piping the stormwater to the toe of the slope is also a good choice as significant erosion would occur with an open drain.

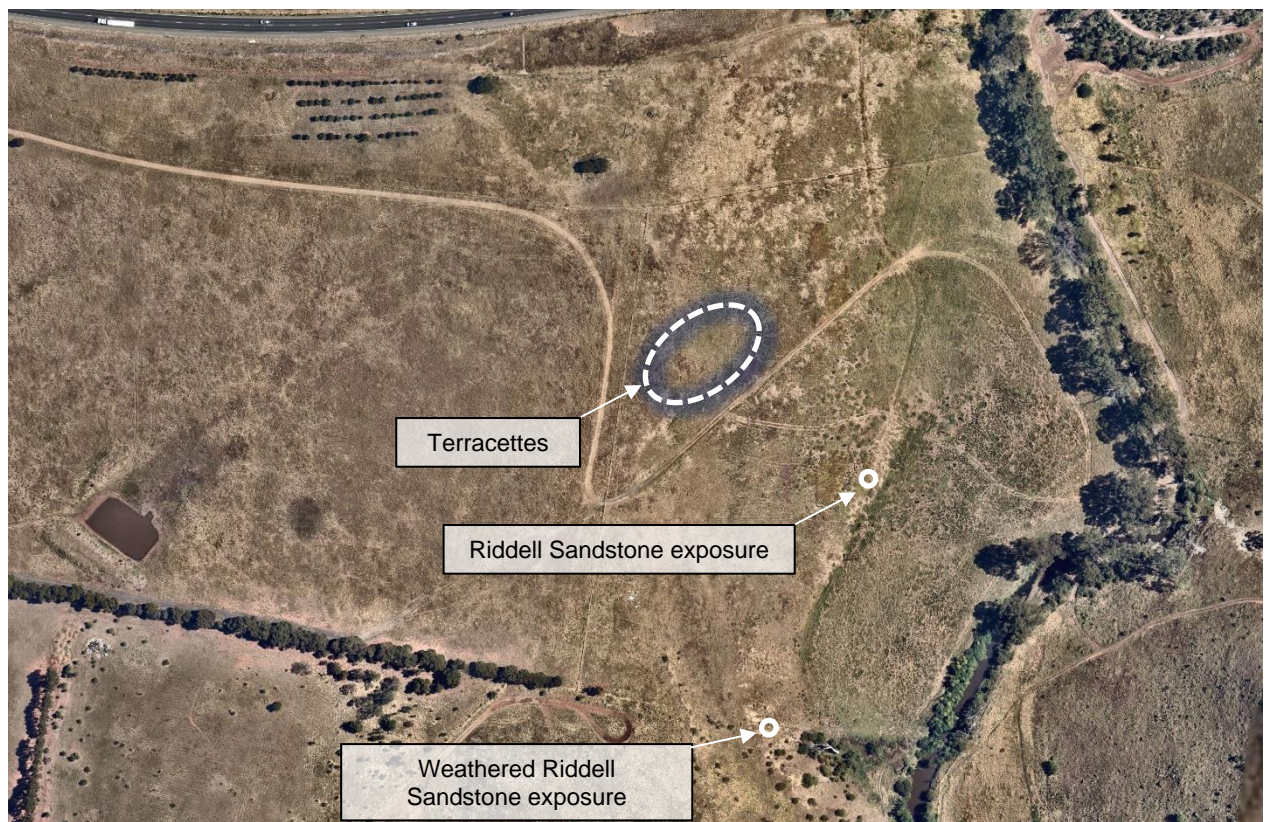
Image 10 – Marked up Nearmap image with geological exposures.

Exposures of the Ordovician Riddell Sandstone were also noted at elevations of 103 m and 93 m AHD in the northern part of the site.

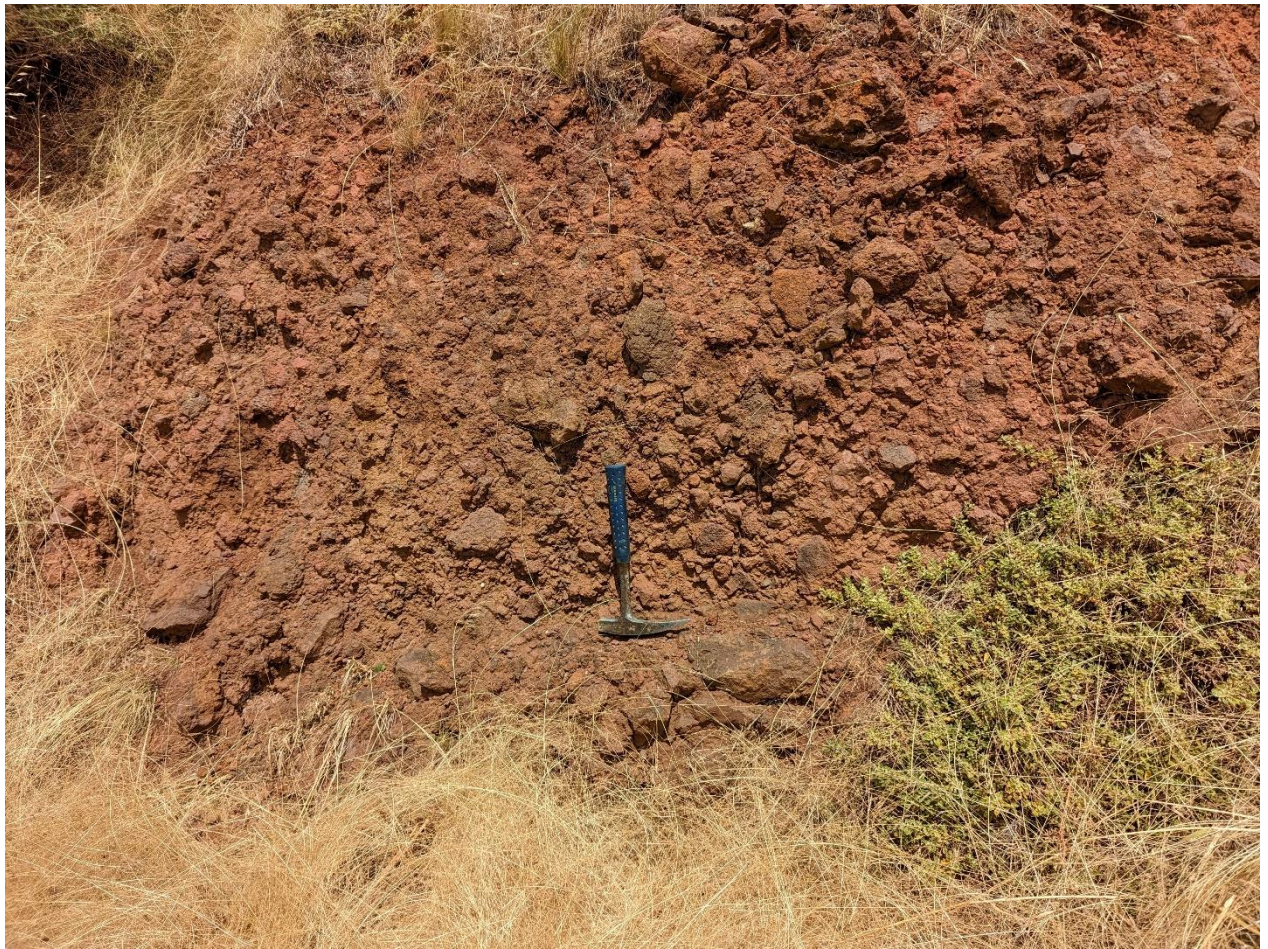
Image 13 – Base of basalt / potential contact with colluvium above less steep track.

There were no signs of recent large-scale landslides on the eastern escarpment. Some terracettes (indicative of soil creep) were noted near the northern end of the site. Some potential ancient landslides could be present above the gentler track as evidenced by change in grade of the slopes and can be seen

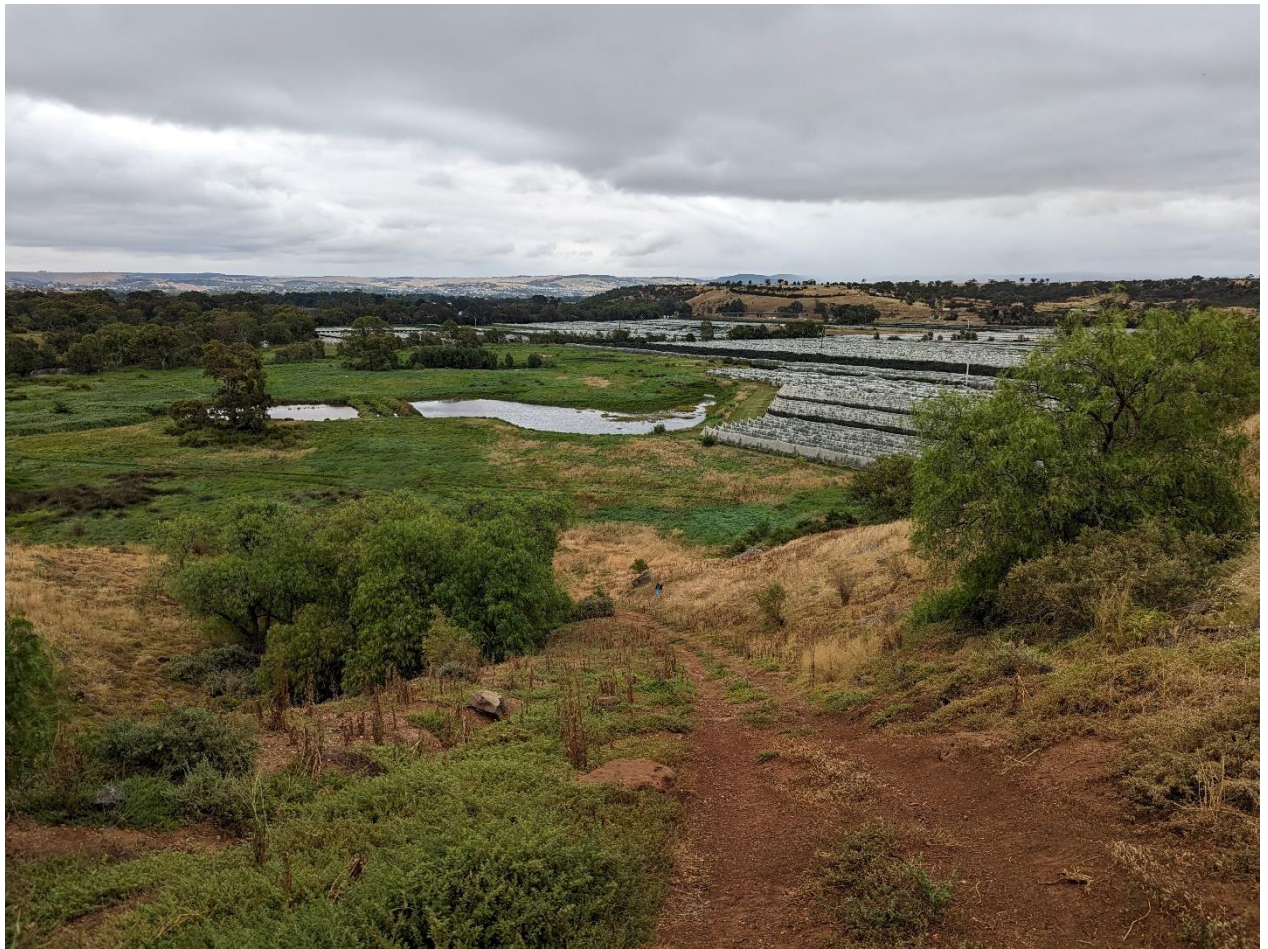
Image 18 – Proposed pipeline route.

The existing pumping station pipeline route, which contains sewer and stormwater lines, is along the side of an existing gully, and as with other gullies has basaltic clay colluvium within the gully, which appears to be protective, and is stable. This is a good choice for the proposed stormwater outfall due to the favourable conditions and previous successful construction.

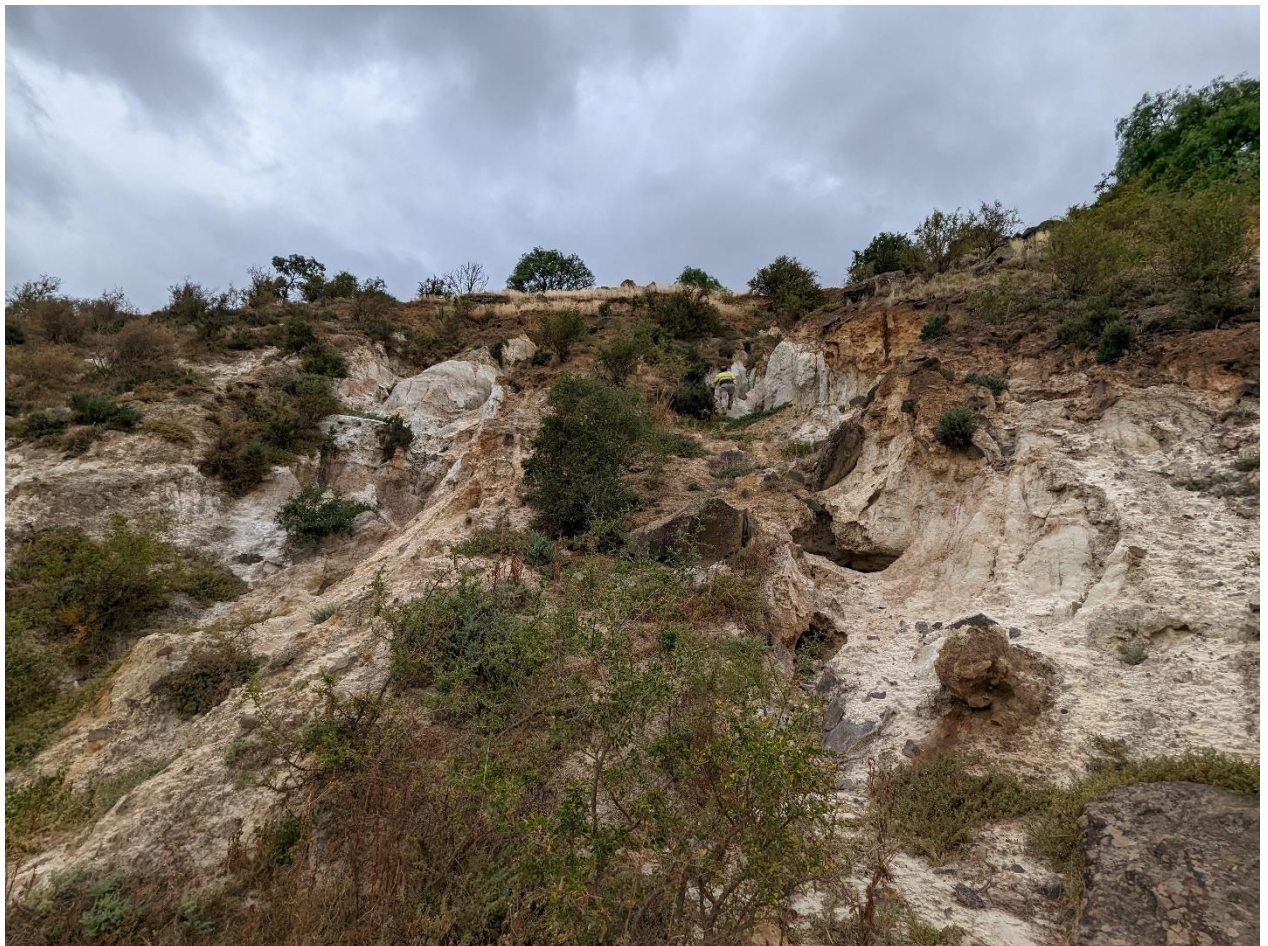
Image 19 – Severe erosion below spring.

Many gullies are incised in the slopes. On the ridgelines, many contacts between the basalt and the underlying Werribee Formation are visible. Springs have previously formed at the contacts on these ridgelines, with four locations showing evidence of recent water flow and soil movement, with locations shown on Image 17 below. No seepage was noted at the spring locations during the investigation. It is not known how regularly the springs flow, although lack of vegetation at the spring outfall locations indicate it is not a rare event.

A major erosion zone is present just to the north of the abandoned houses situated mid-slope. The erosion is considerable and has formed large, deep, solution features and vertical to sub-vertical slopes. The runoff from the erosion crosses the track at the base of the escarpment and enters the apple orchards to the west of the site.

- The rate of these erosion process will be reduced by the development due to the substantial improvement in drainage conditions proposed.
- The failure of the fill in the DOTP road reserve is outside of the property boundary and does not affect the development, however, the DOTP should be advised of this issue.

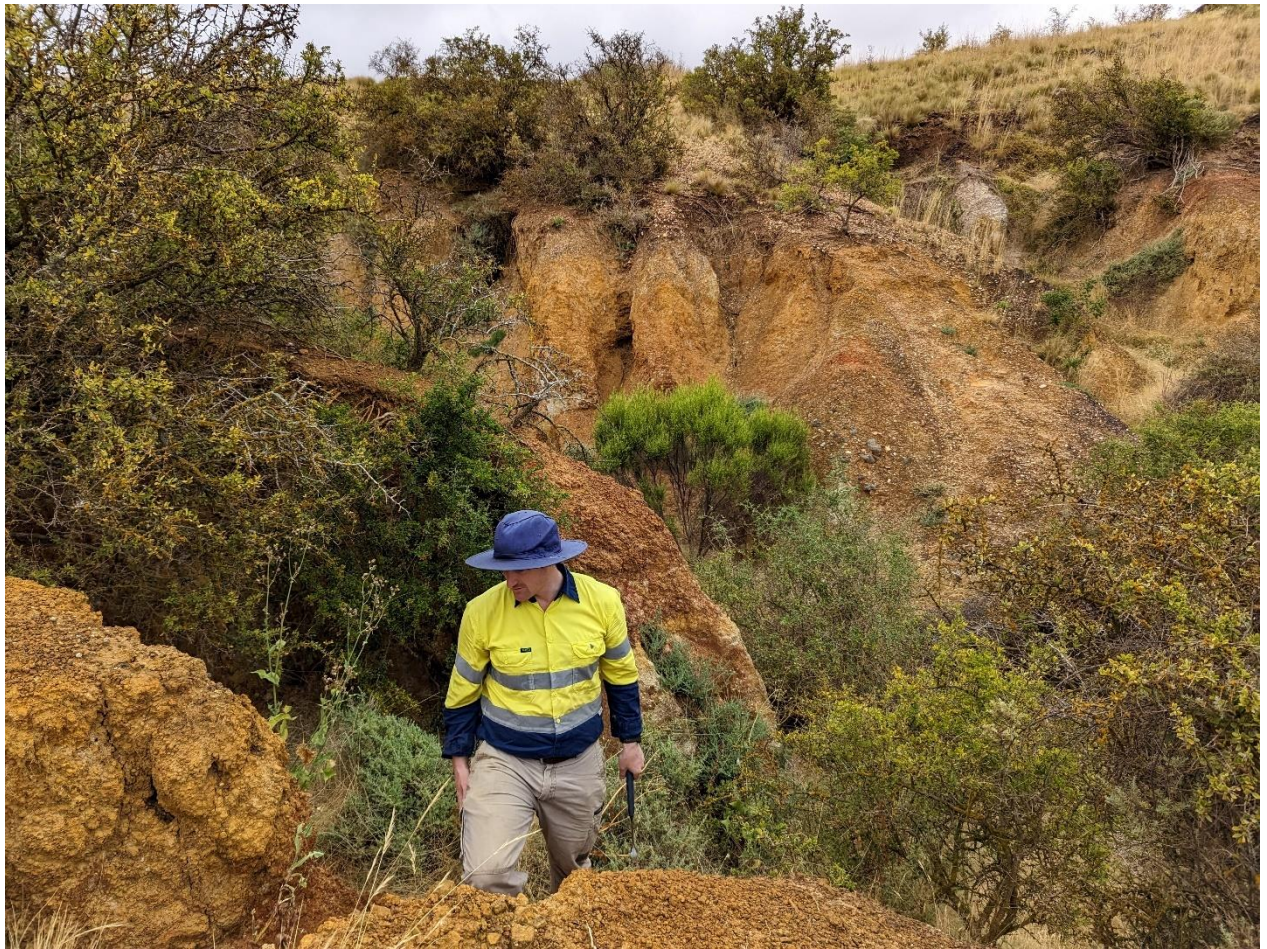
Image 22 – Gully erosion.

The gullies generally appear similar to the eastern escarpment, where they are well vegetated and appear to be replenished with basaltic clay colluvium.

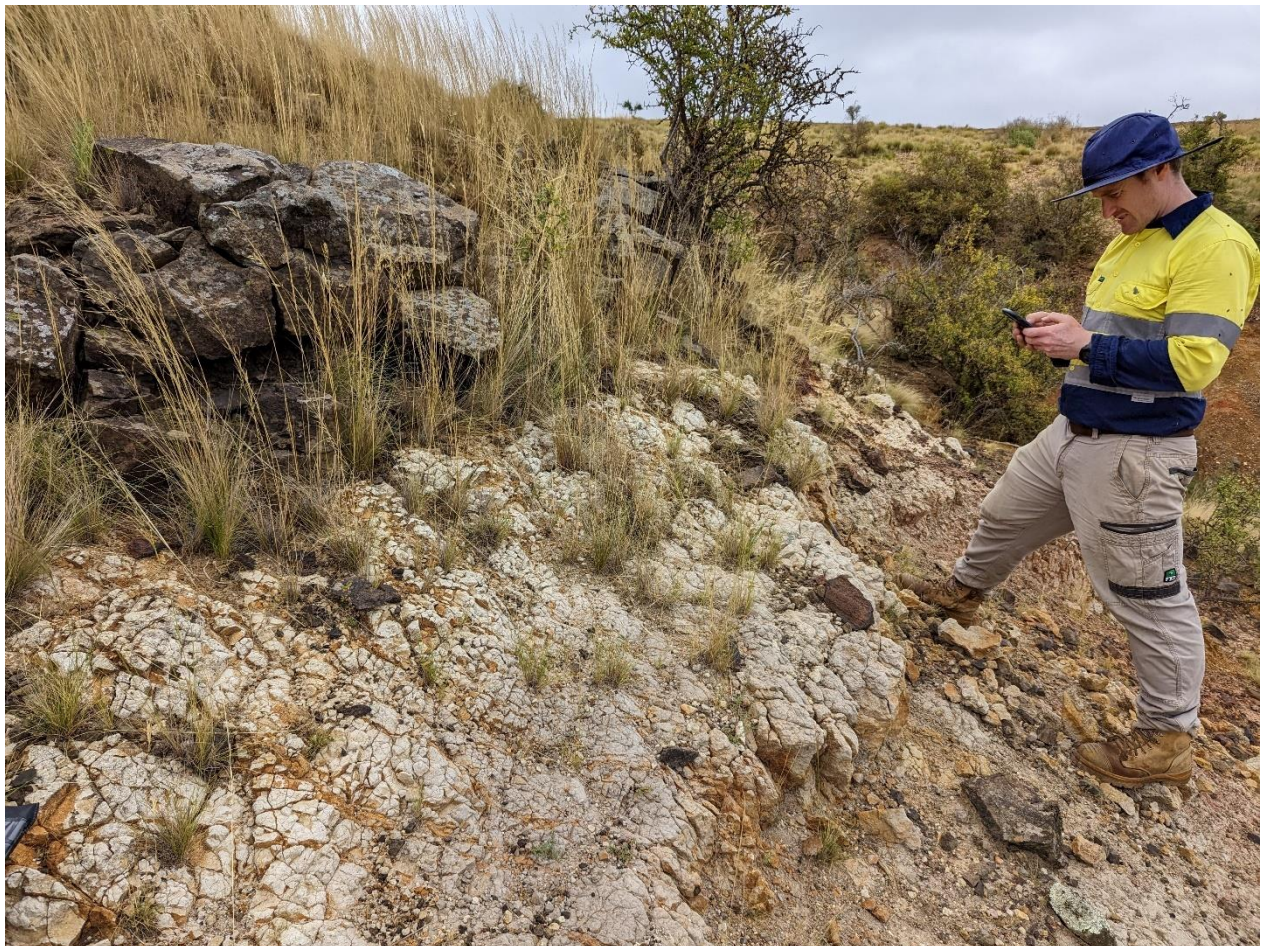
Image 23 – Clear geological contact between basalt and Werribee Formation.

The top of the basalt was measured between 127 m AHD in the south, to 136.5 m AHD in the north, reflecting the overall general slope of the plateau to the south. The contact with the Werribee Formation was noted in many locations, which was at around 119 m AHD in the south and 127 m in the north, indicating a basalt thickness of around 8 to 10 m. The top of the plateau in the north west of the site is around 140 m AHD reducing to 130 m AHD in the south. Darley Gravel was clearly present in the north half of the site, however, it reduced to negligible thickness towards the south.

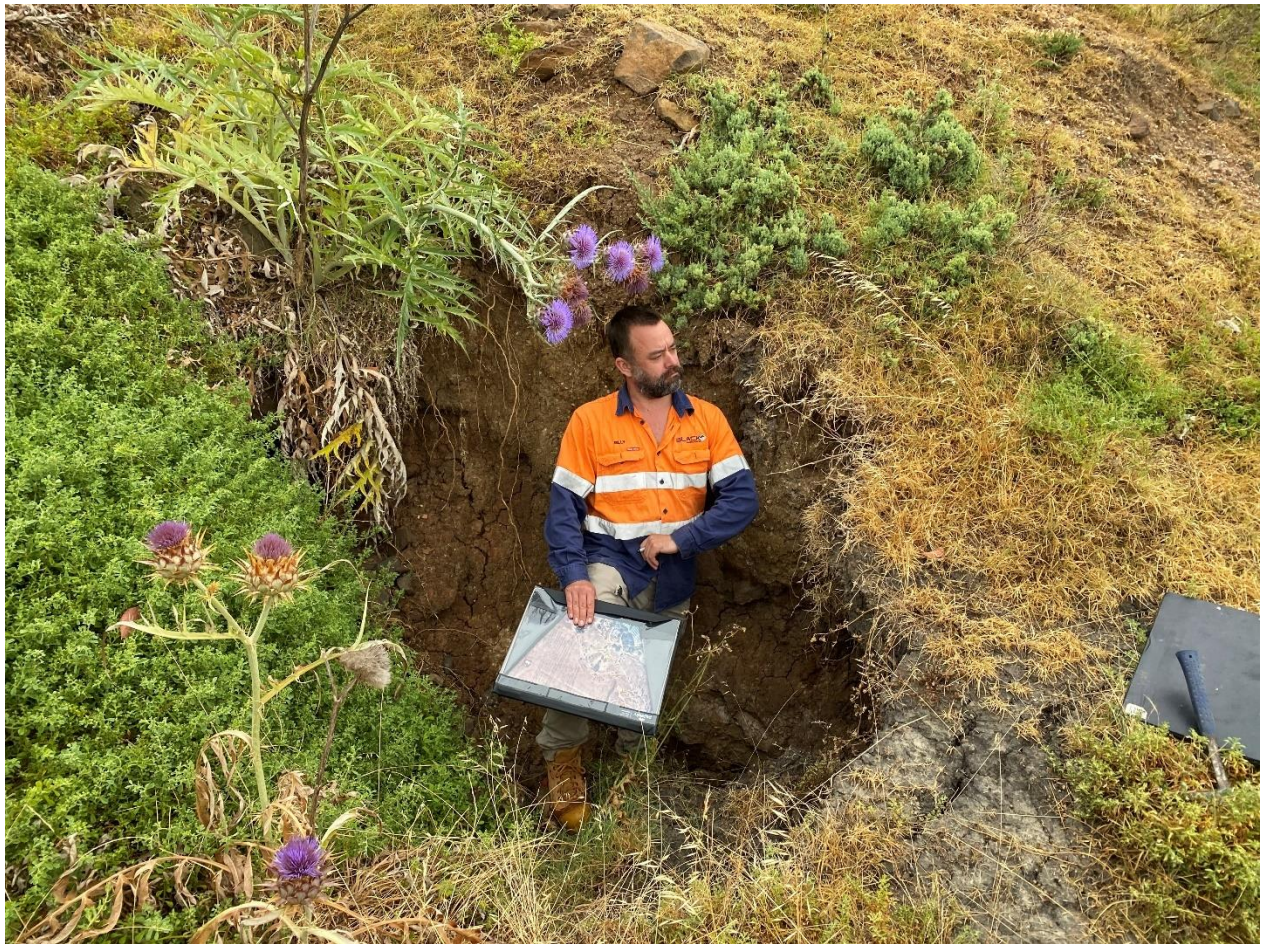
Image 24 – Large solution feature above filled quarry/sand pit, located north of subject site in DOTP road reserve.

To the north of the site, between the north west corner and the Western Highway, significant erosion is also noted. This is in a different form to the erosion in the Werribee Formation, expressed mostly as near vertical piping erosion forming multiple holes spread throughout the slope, although concentrated near the top, below the base of the basalt, and near the toe, just above Cowans Road. This area was previously occupied by the sand pit, discussed in Section 2.1, and is understood to have been filled by VicRoads (now the DOTP) as part of the Western Highway upgrade. The fill is similar in appearance to the Werribee Formation (pale grey and white clay) and is dispersive. It is likely that the Werribee Formation soils excavated as part of the cutting for the Western Highway was used as fill, and this has subsequently failed. Although this is of little relevance to the geotechnical stability of the proposed Hopetoun Park development, it should be highlighted now to provide clarity that the development has not caused this failure.

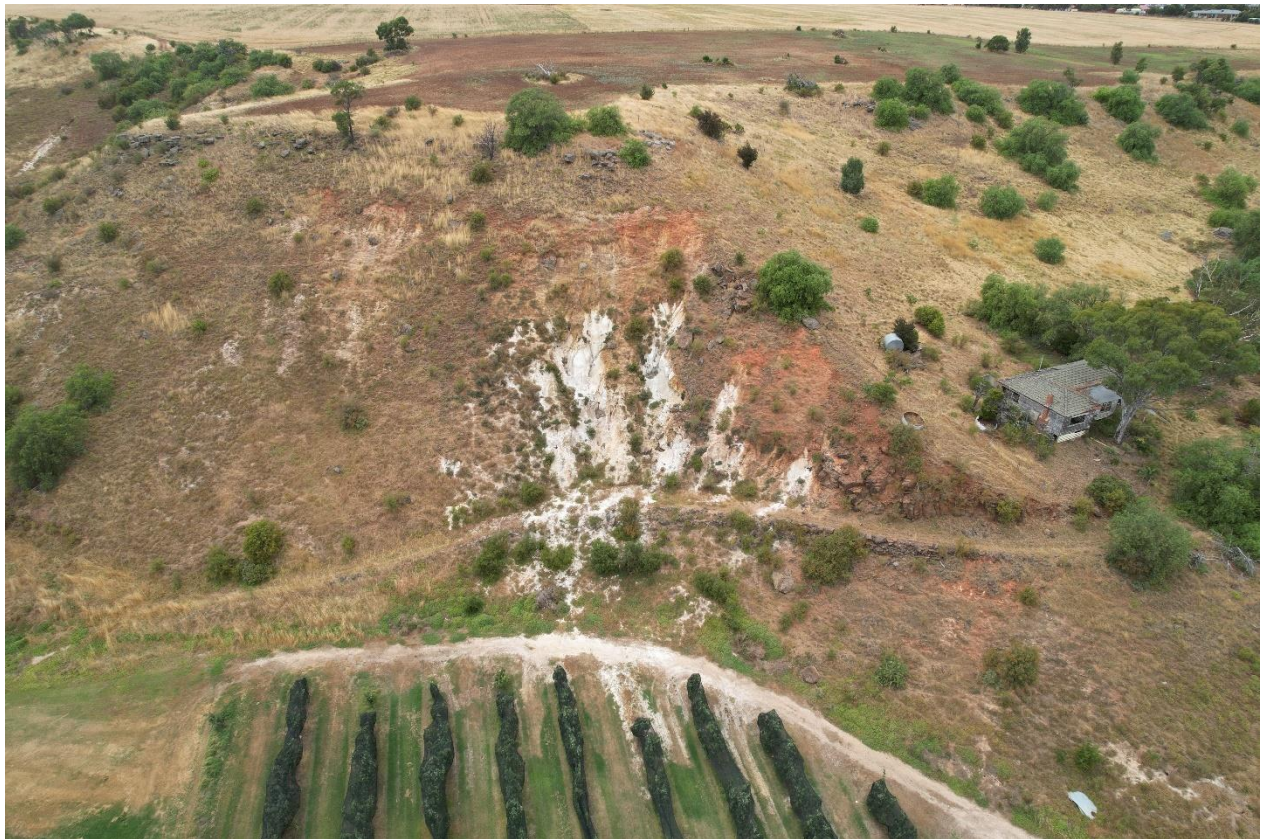
Image 28 – Aerial view of large erosion feature. Abandoned house to the right on ancient landslide feature.

The abandoned houses appear to be situated on an ancient landslide, evidenced by the change in grade and also the presence of basalt blocks at a much lower elevation than expected. It is difficult to estimate the age of the landslide, however, the presence of established vegetation, the muted surface features, and difficulty in identifying the landslide in the first place indicates a minimum age in the thousands of years.

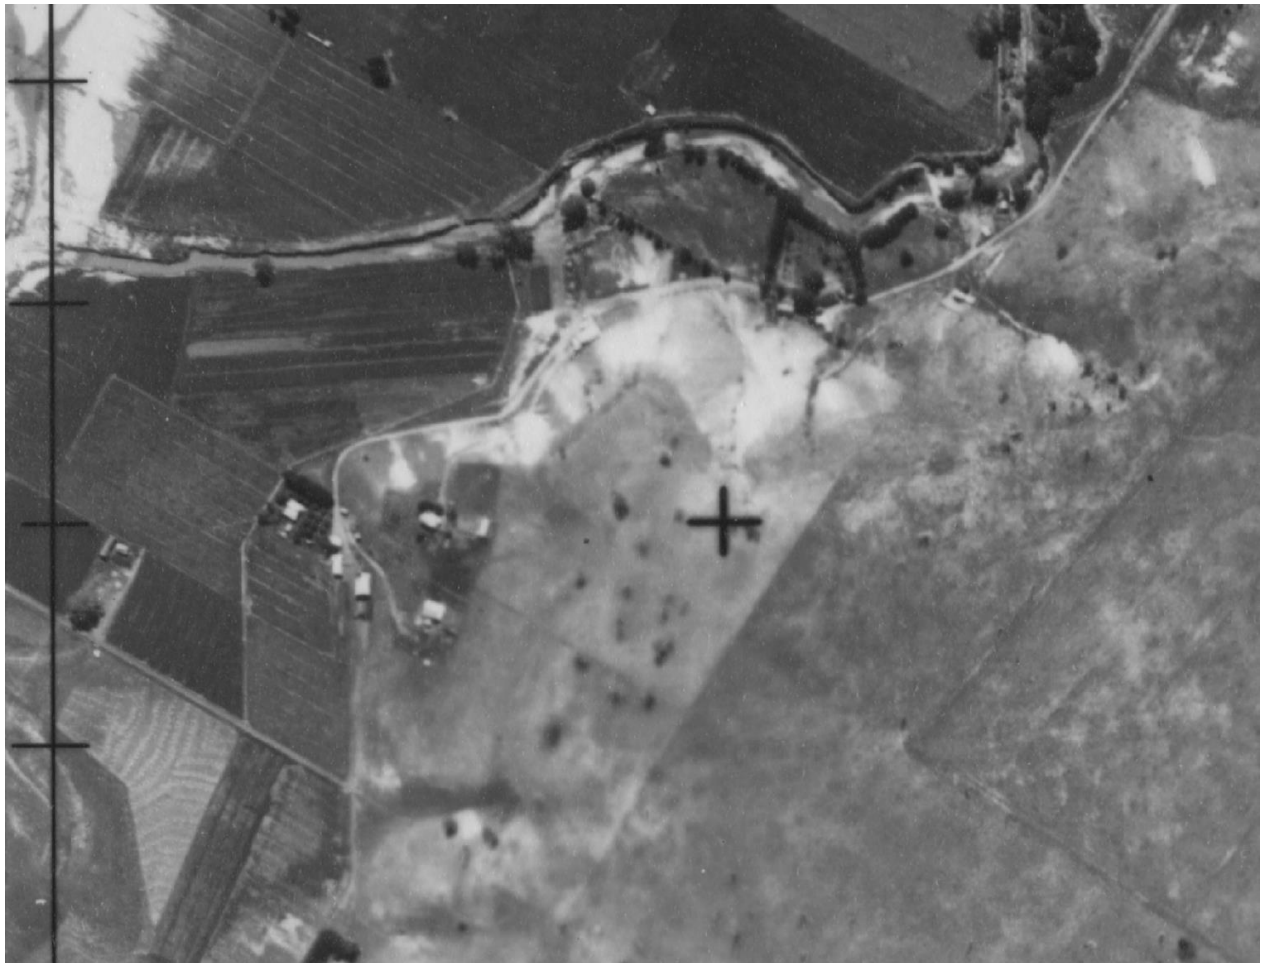
Image 31 – 1946 aerial photograph showing similar erosion features near the (now) abandoned houses.

Historical aerial photos were obtained for the site. Of note, the significant erosion noted on the western escarpment is evident as far back as the photos go (1946 is the earliest obtained) and does not appear to have changed in the intervening years. This is a good indication that the erosion has been a slow process.
