Preliminary Environmental Site Investigation

Super Lots A, B, C, D & E - Underbank Development

Prepared for Plenti Property Pty Ltd Prepared by Tonkin & Taylor Pty Ltd Date February 2024 Job Number 1008283.2000 v04

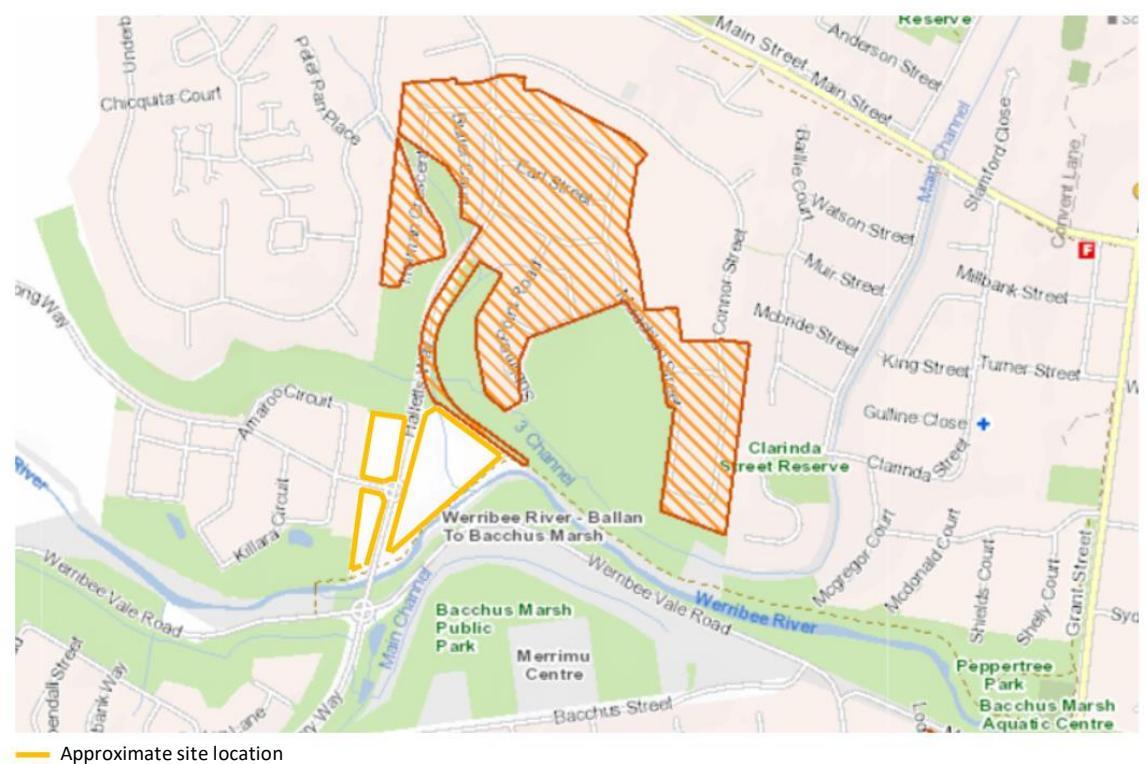
Figure 3.4.1. Environmental Audit location

A Certificate of Environmental Audit was issued for a property on Halletts Way, Bacchus March VIC (dated 10 August 2015) north of the subject site. The location of the Environmental Audit boundary is depicted in the Figure 3.4.1, on the following page.

Location of Environmental Audit EPA CARMS 73064-1

The previously environmental audited property was previously used as agricultural and residential land, including minor quarrying activities to the south, and remained vacant from 1990 to the date of the audit. A soil investigation encountered fill soils in the central southern area of the property with depths in excess of 3.5 m bgl comprising gravels and silts. A layer of basalt gravels was noted to be present across the majority of the central southern portion of the property. The property also contained stockpiles of soil and wastes (including metal, timber, bricks, plastics) and earthen bunds comprising clays with cobbles consistent with natural soils were observed. No intrusive groundwater investigation was conducted in conjunction with the soil investigation.

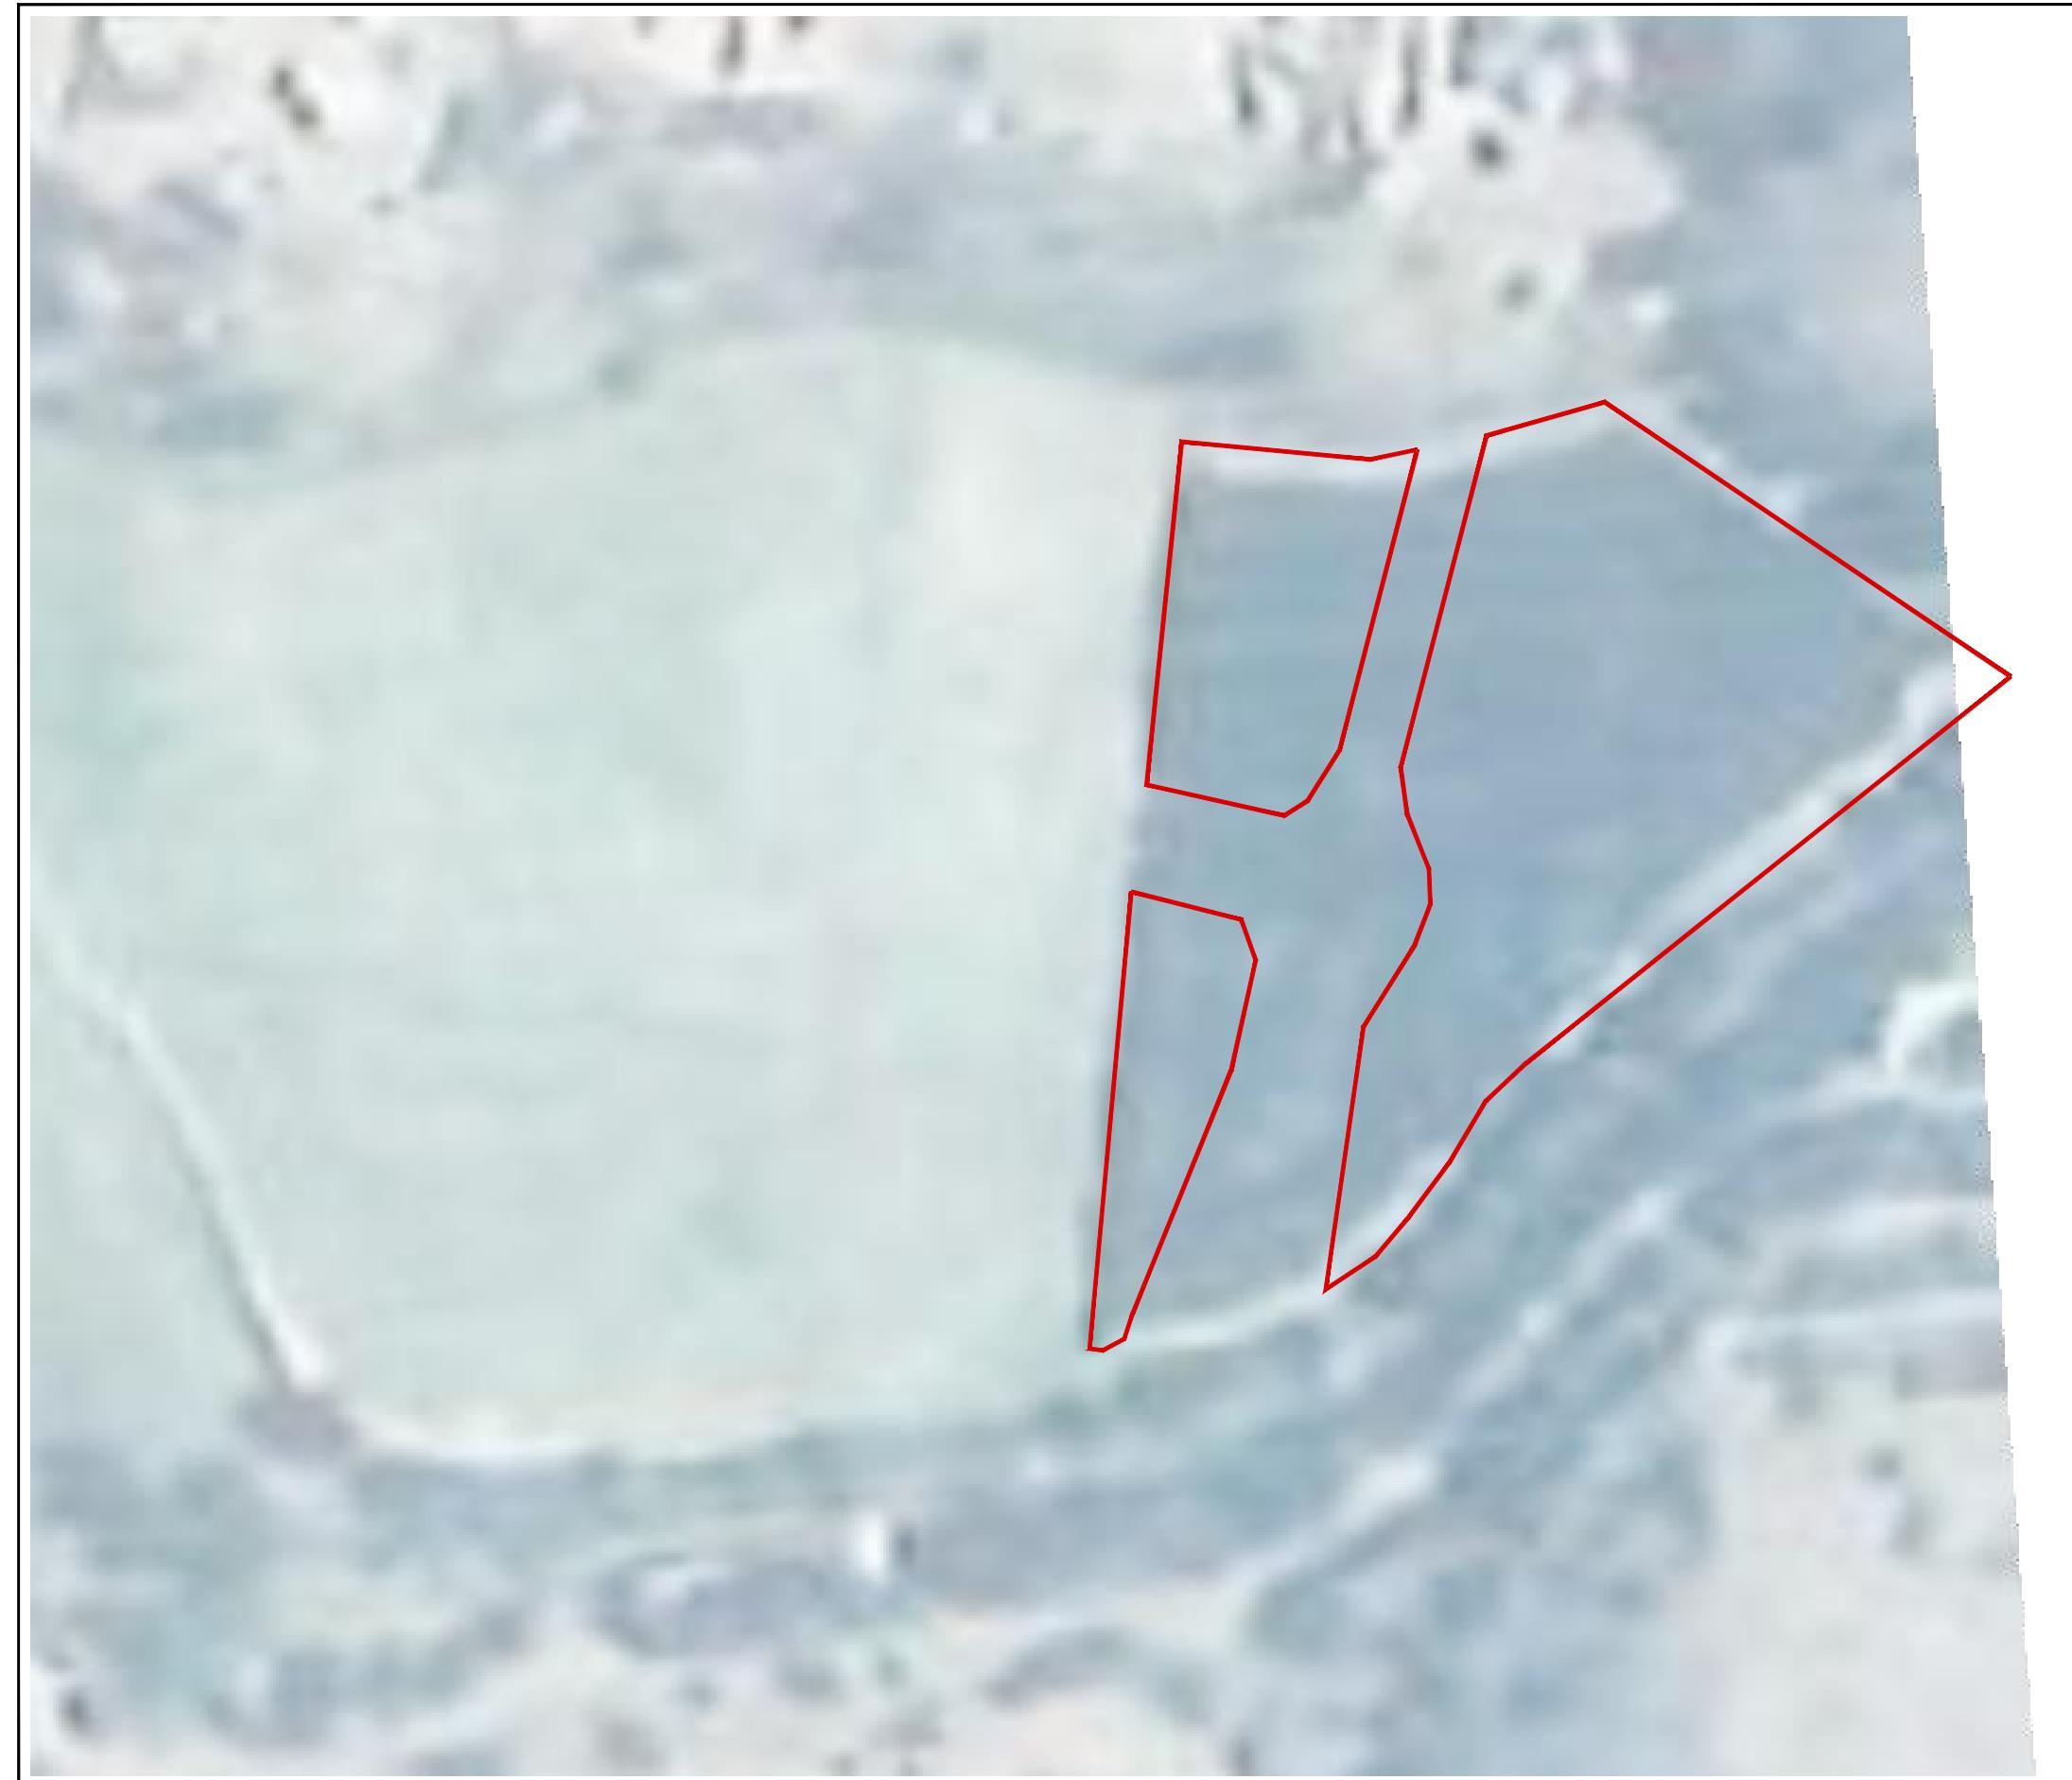
SCALE (A3) 1:2000 FIG No. AERIAL 1990

TITLE PRELIMINARY ENVIRONMENTAL INVESTIGATION HISTORICAL AERIAL PHOTOGRAPH - 1990

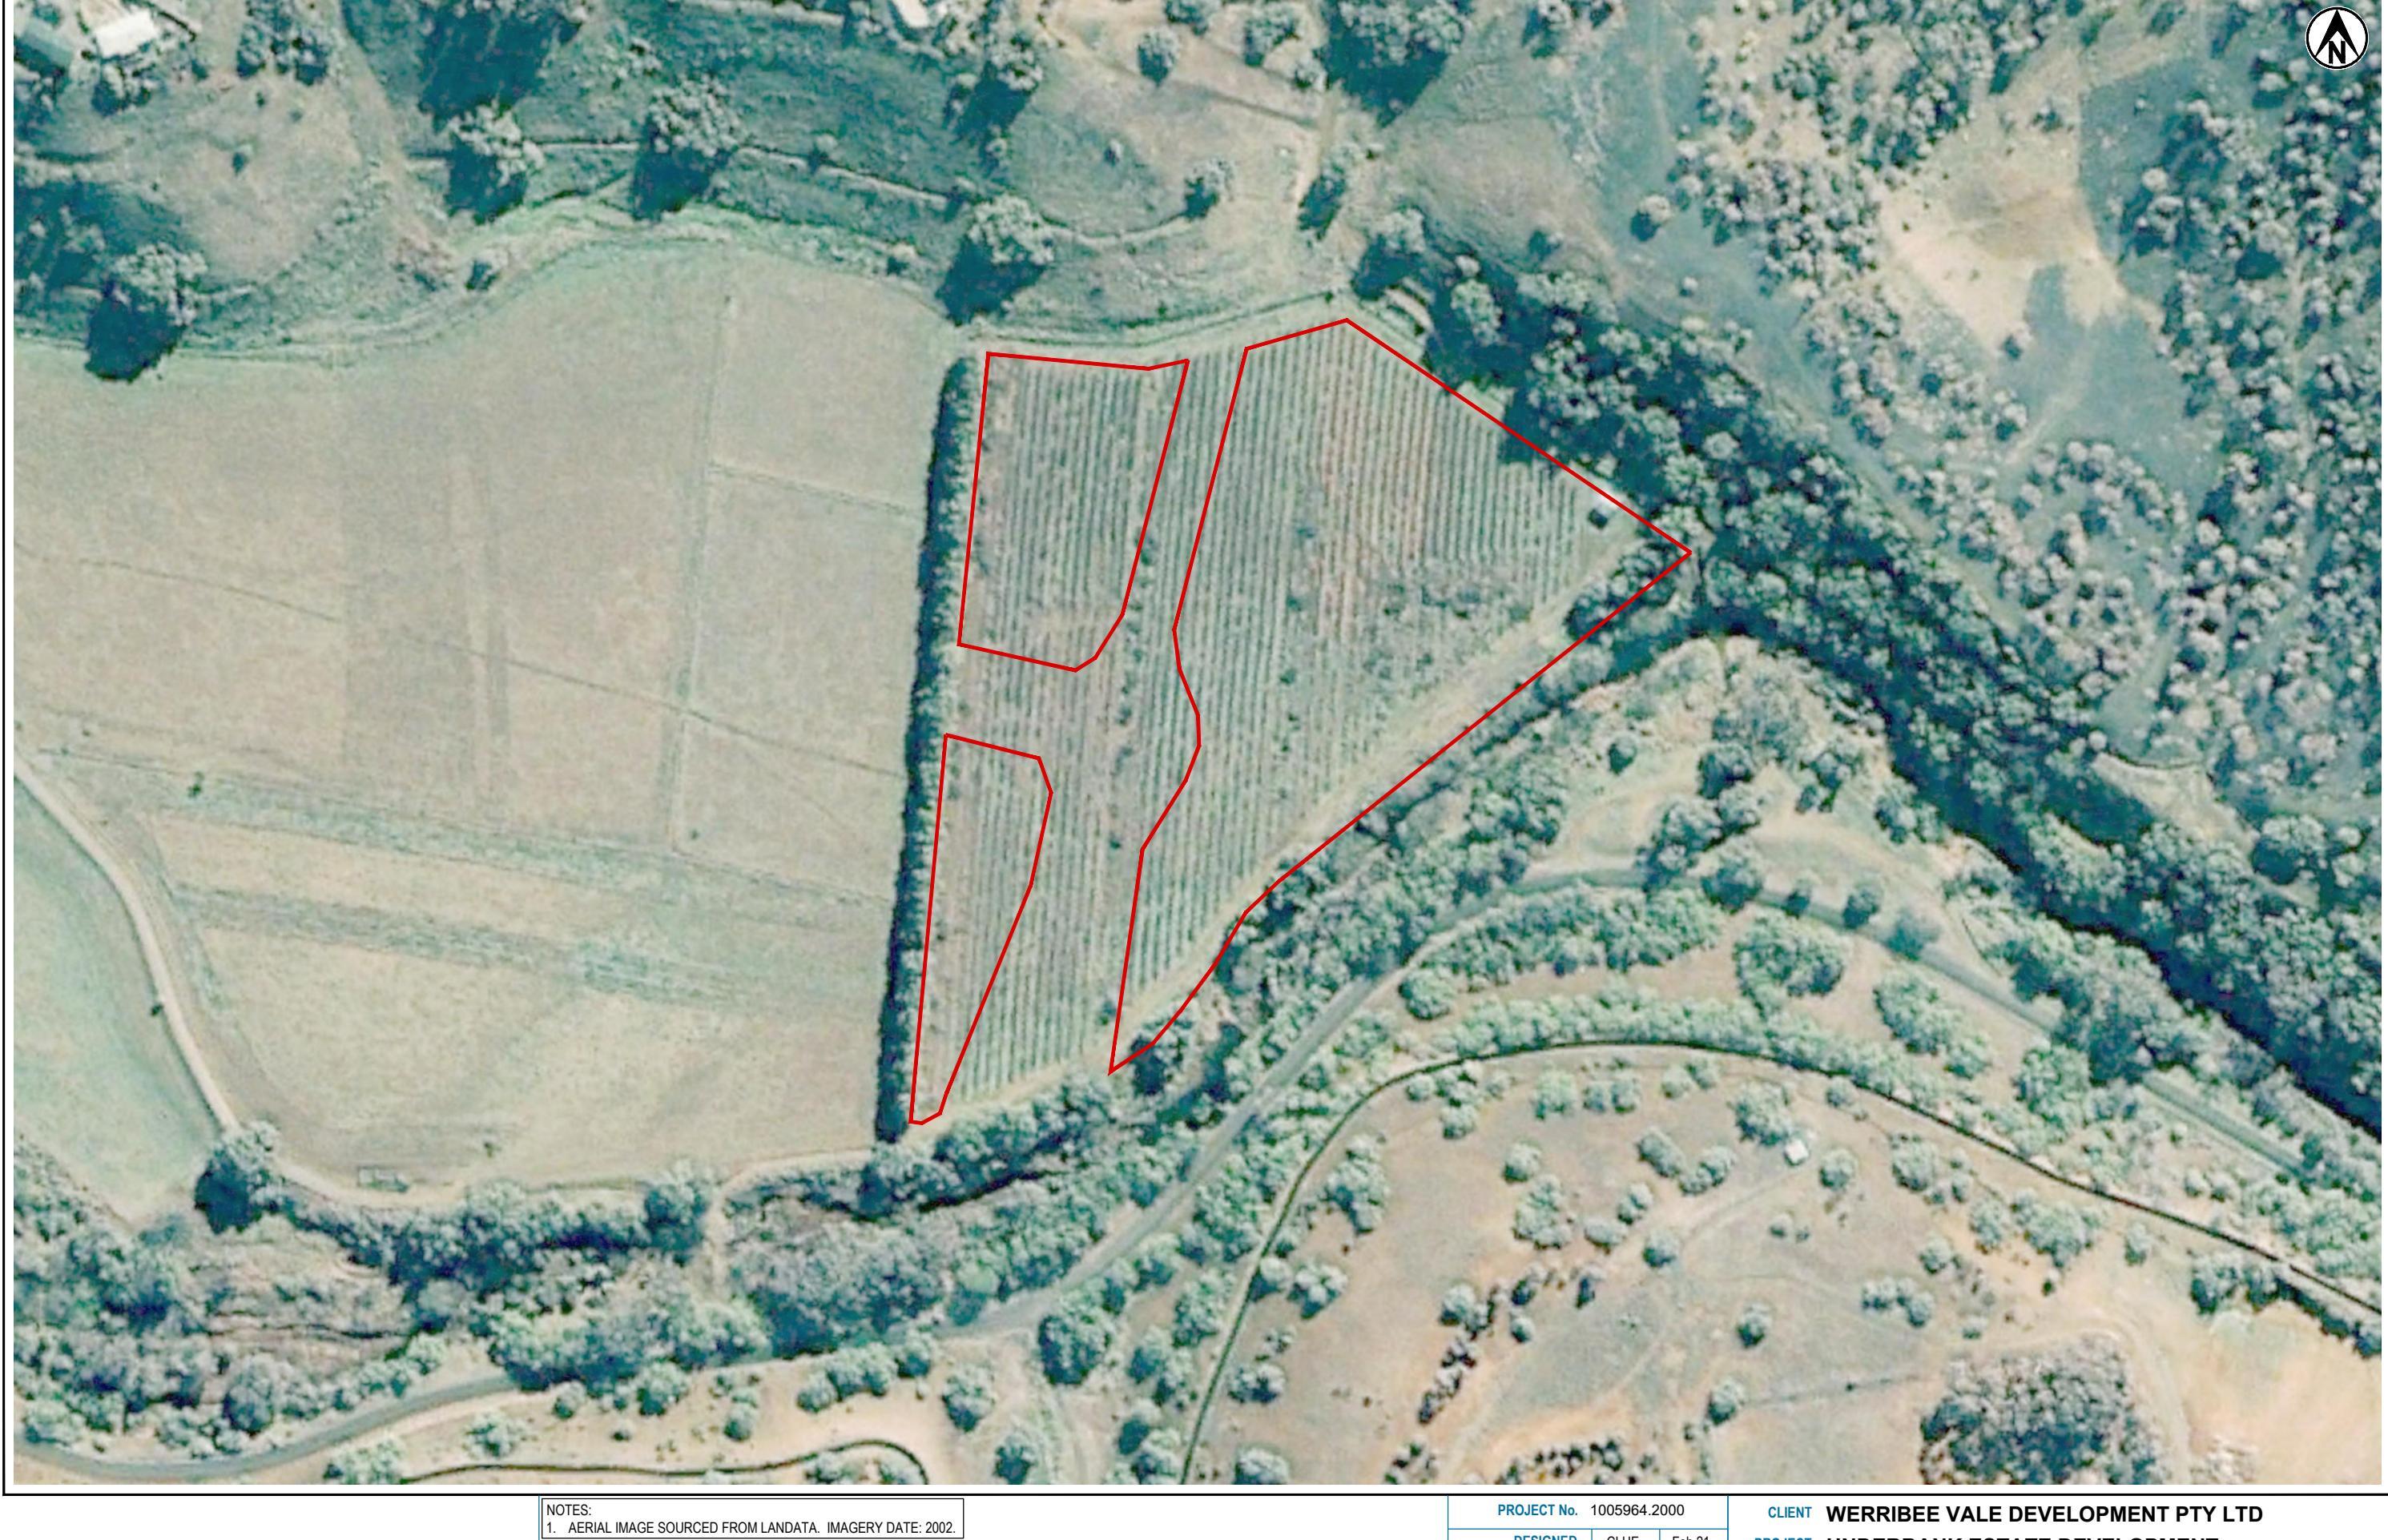
SCALE (A3) 1:2000 FIG No. AERIAL 2002

TITLE PRELIMINARY ENVIRONMENTAL INVESTIGATION HISTORICAL AERIAL PHOTOGRAPH - 2002

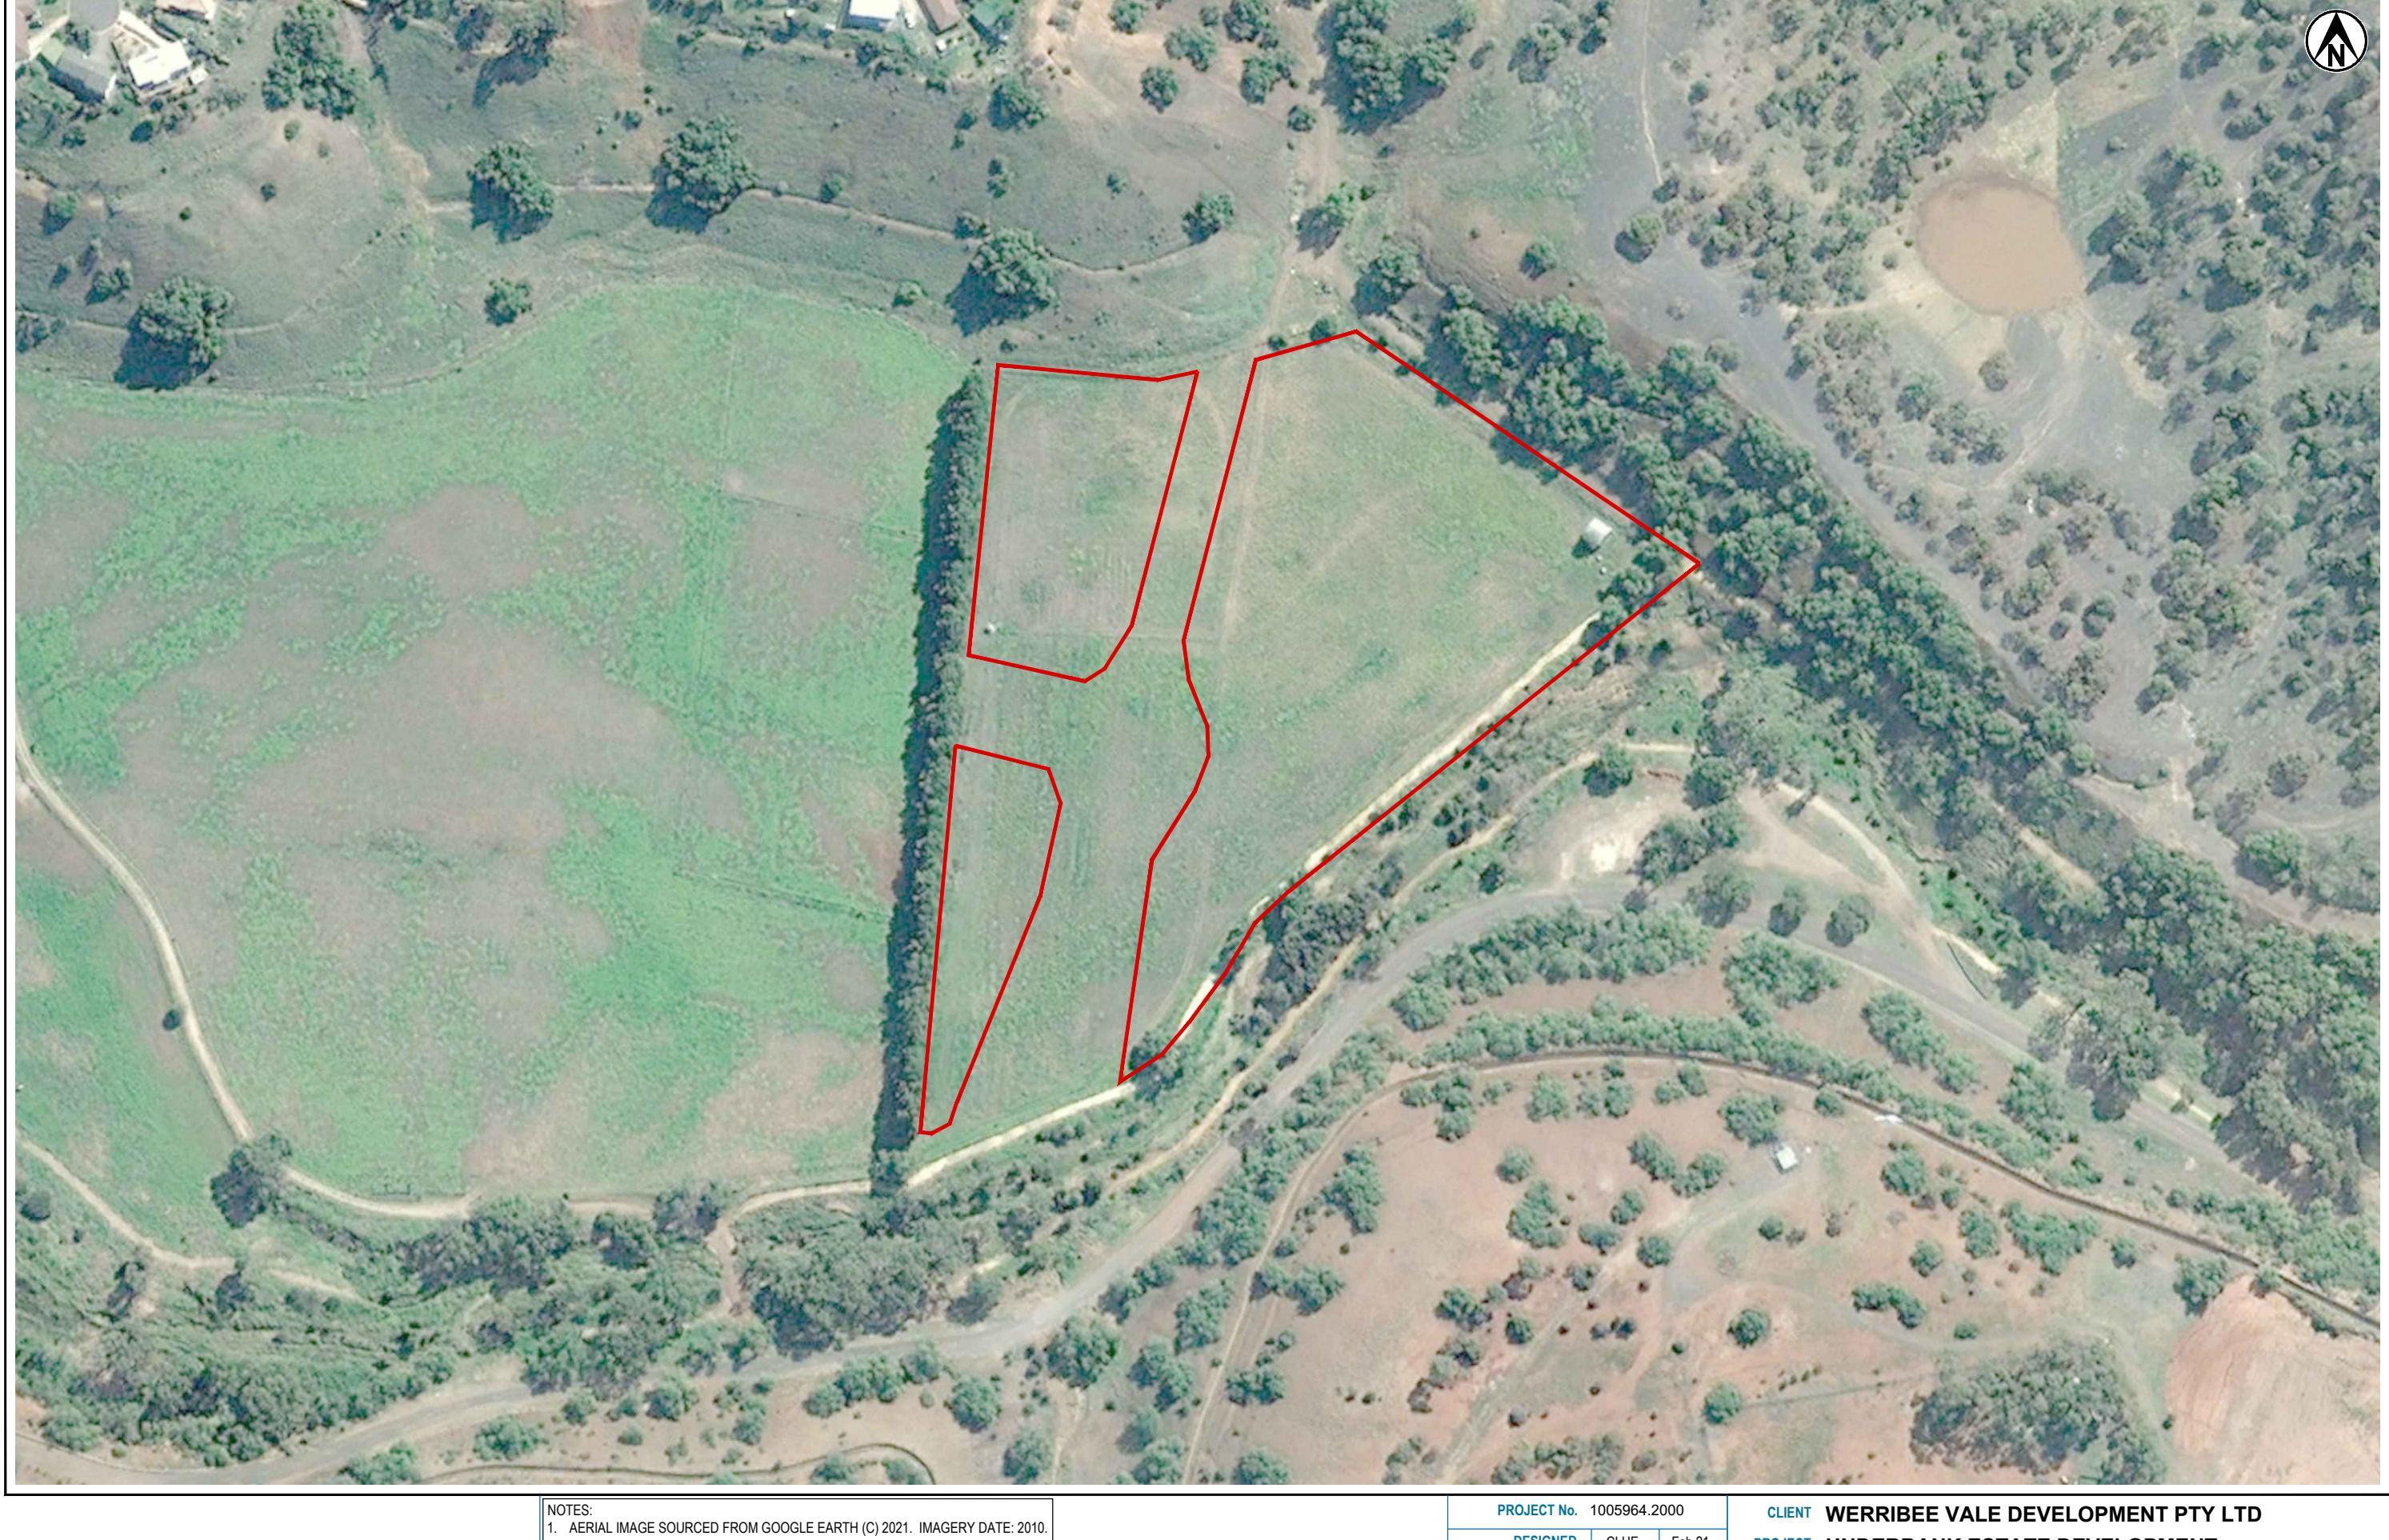
SCALE (A3) 1:2000 FIG No. AERIAL 2010

TITLE PRELIMINARY ENVIRONMENTAL INVESTIGATION HISTORICAL AERIAL PHOTOGRAPH - 2010

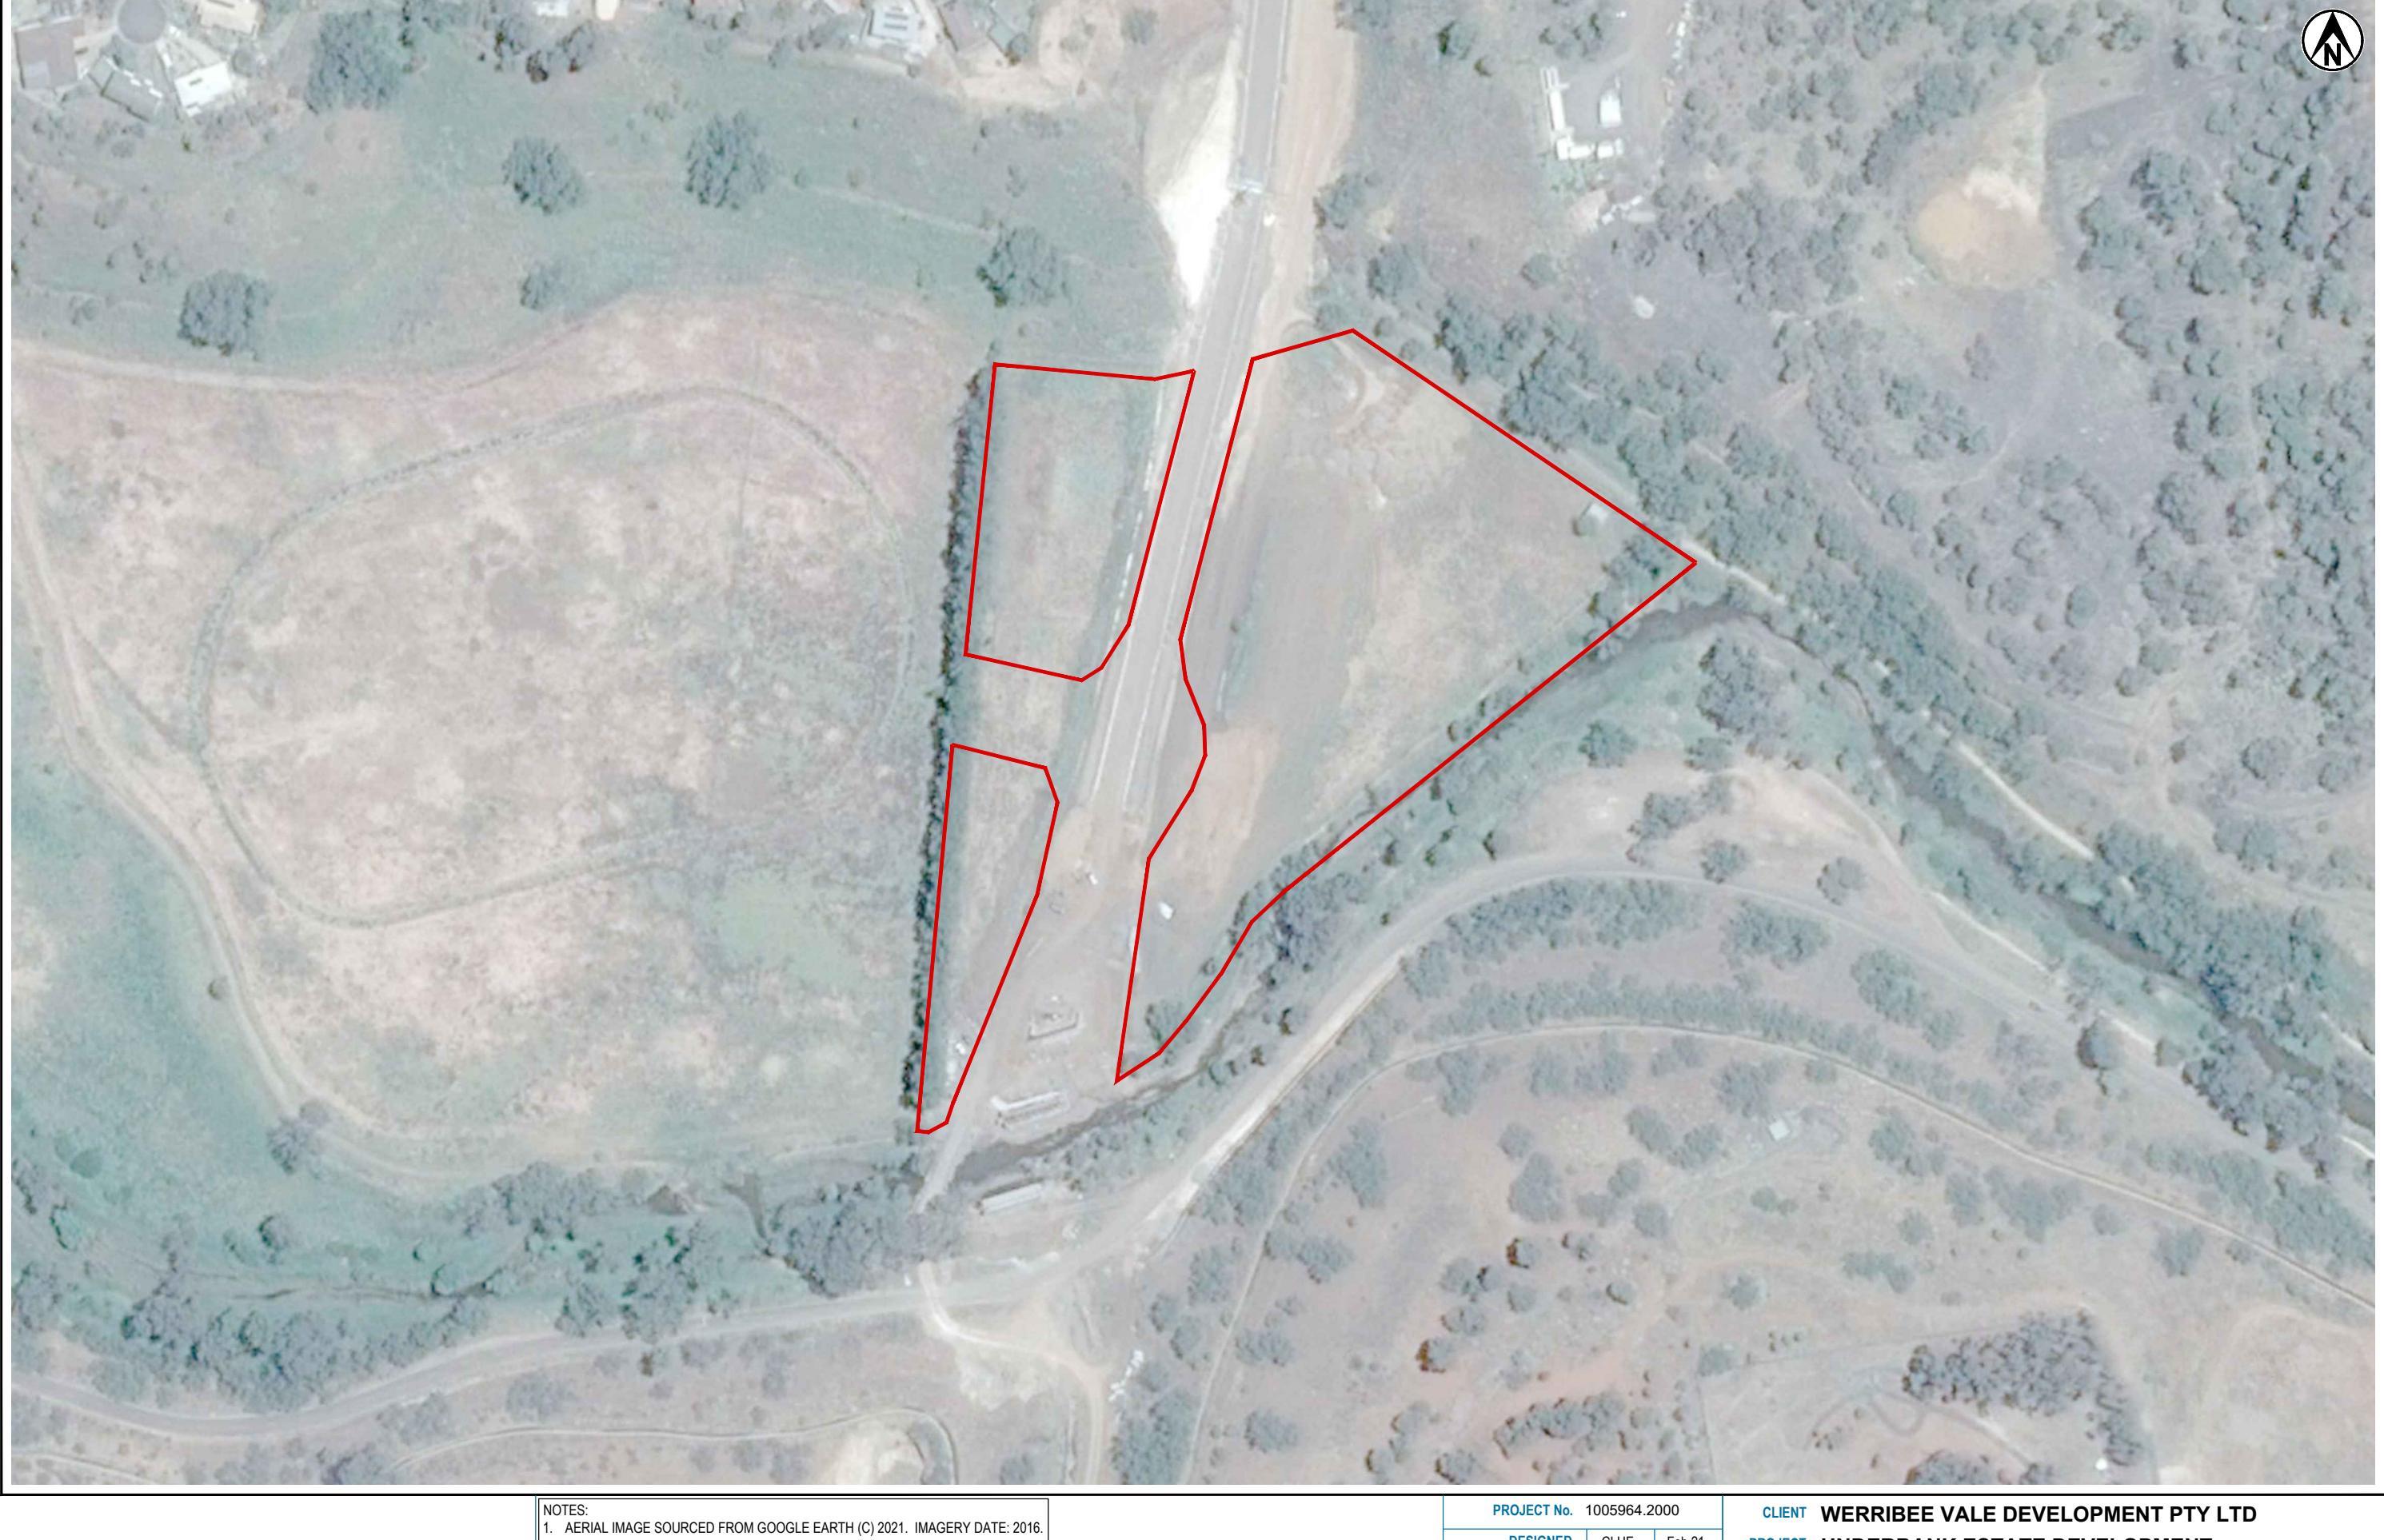
SCALE (A3) 1:2000 FIG No. AERIAL 2016

TITLE PRELIMINARY ENVIRONMENTAL INVESTIGATION HISTORICAL AERIAL PHOTOGRAPH - 2016

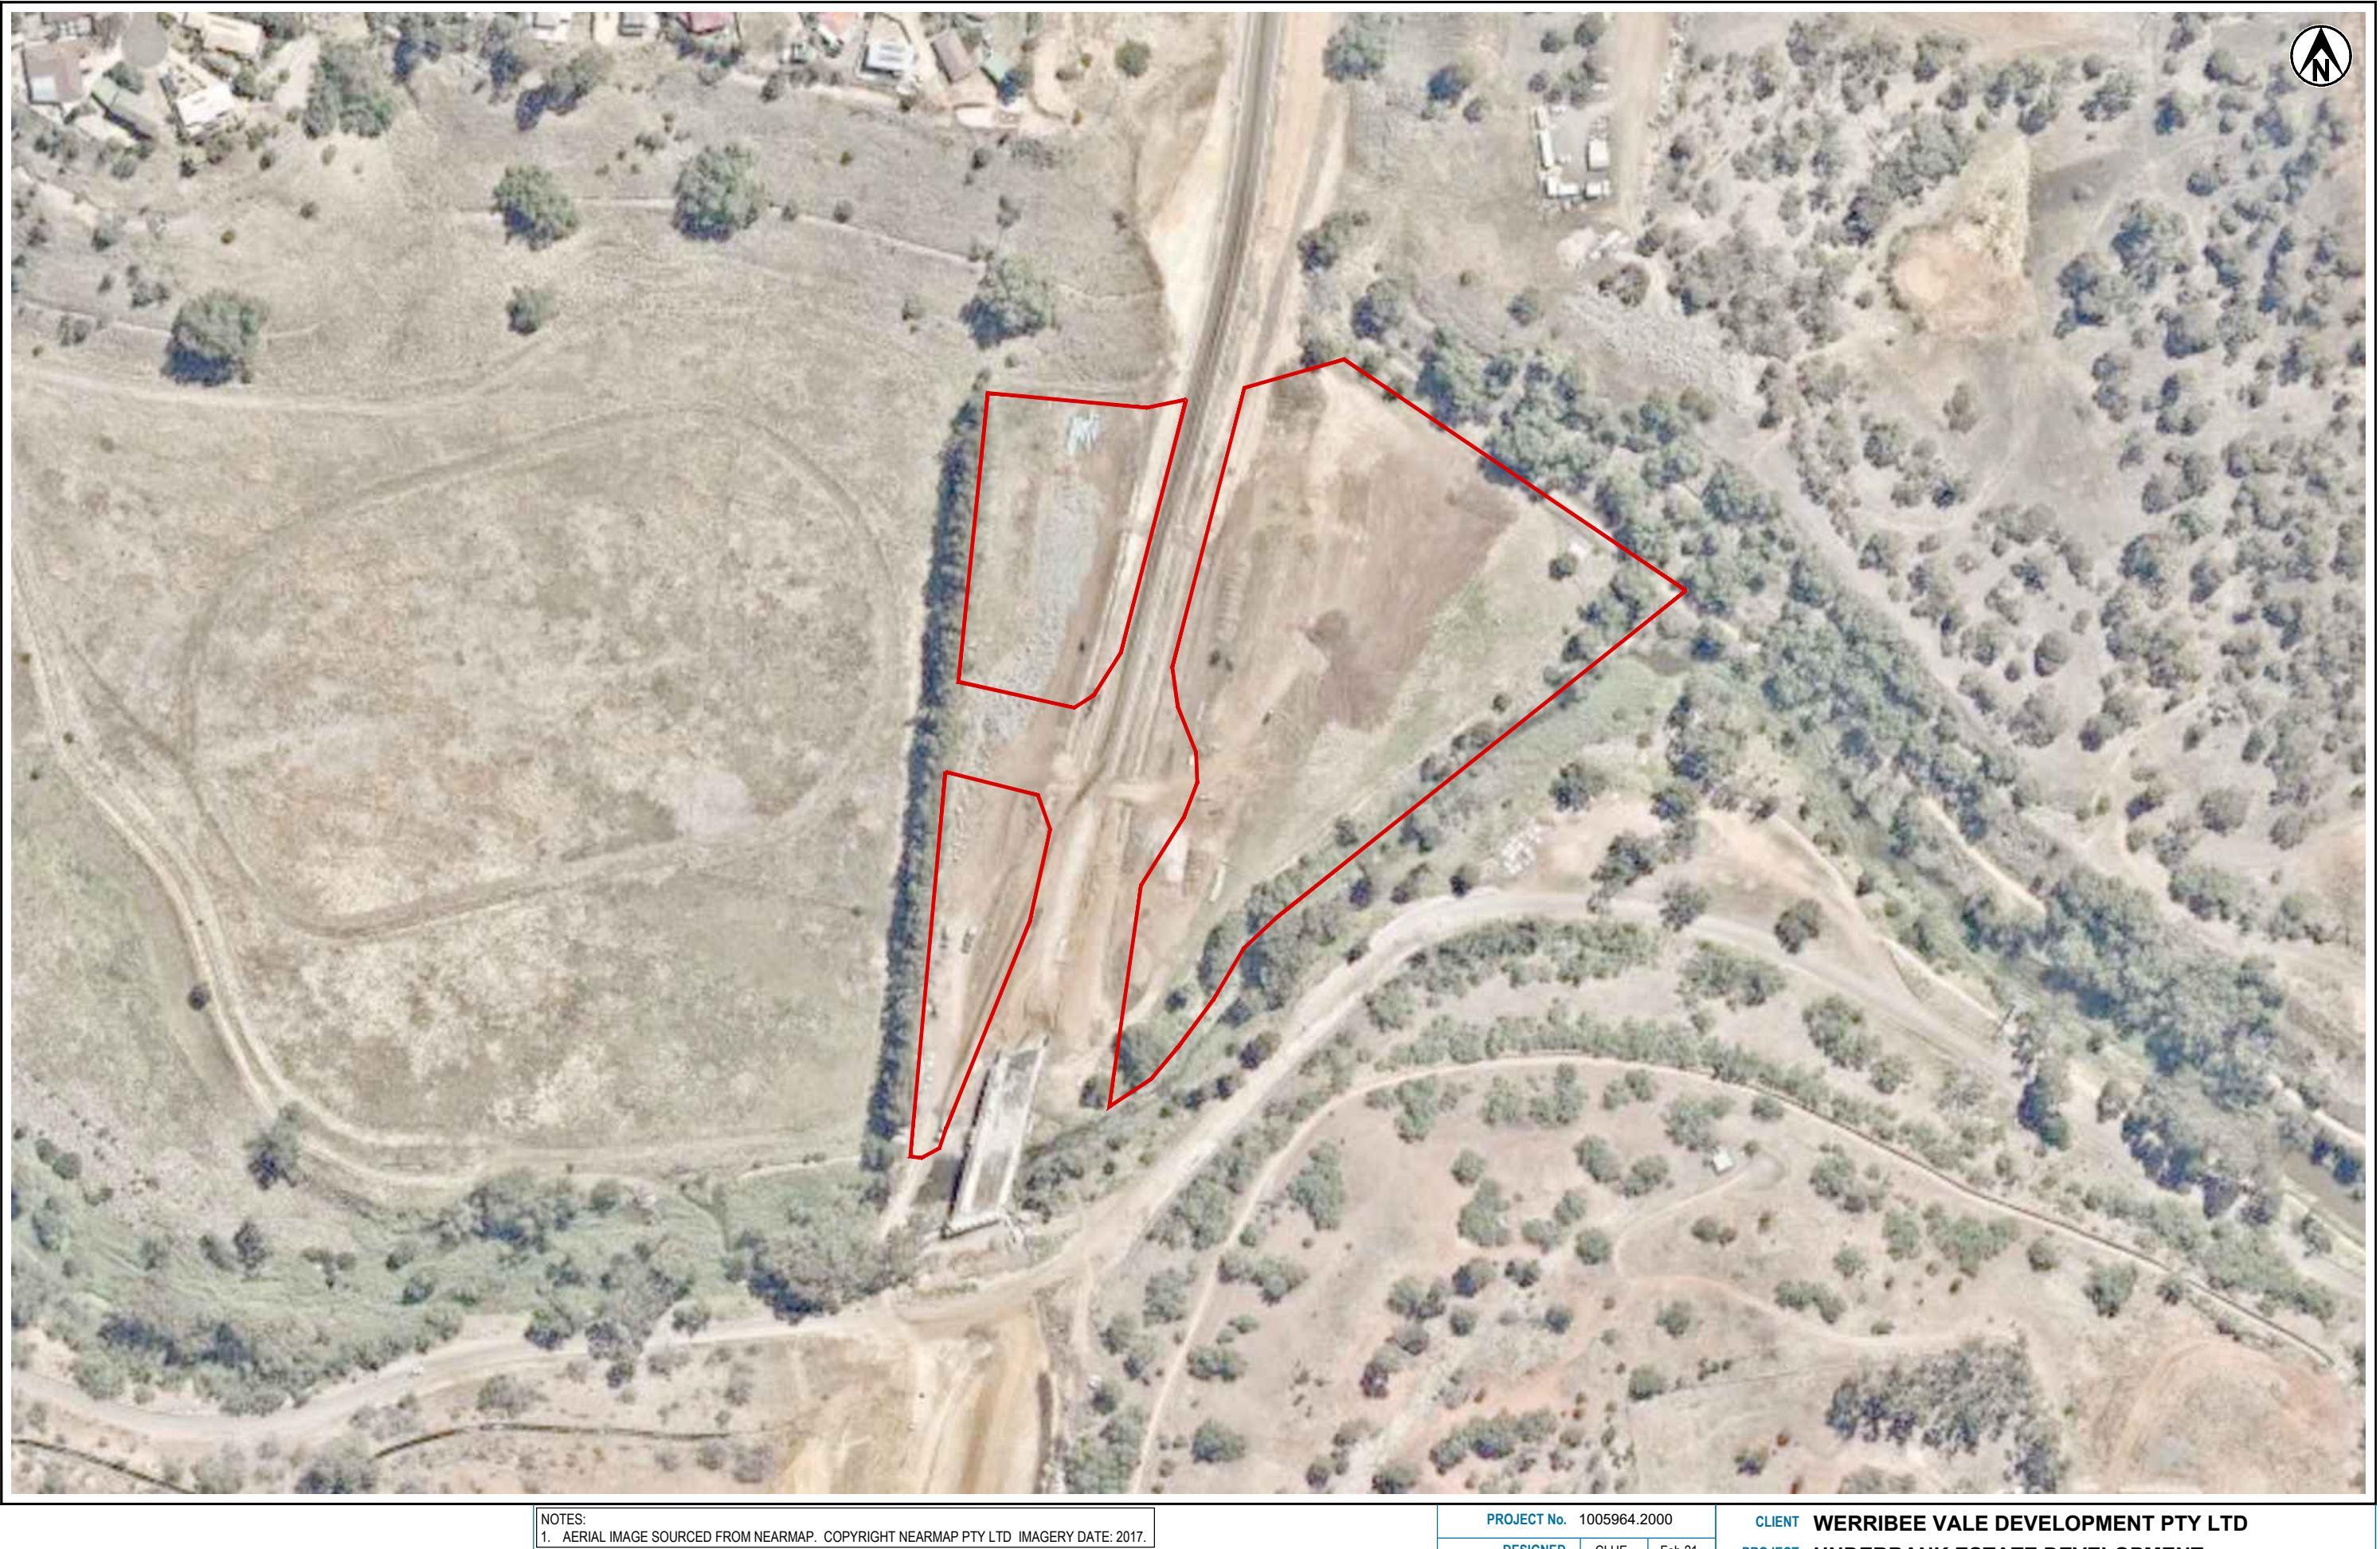
SCALE (A3) 1:2000 FIG No. AERIAL 2017

TITLE PRELIMINARY ENVIRONMENTAL INVESTIGATION HISTORICAL AERIAL PHOTOGRAPH - 2017
