Preliminary Environmental Site Investigation

Super Lots A, B, C, D & E - Underbank Development

Prepared for Plenti Property Pty Ltd Prepared by Tonkin & Taylor Pty Ltd Date February 2024 Job Number 1008283.2000 v04

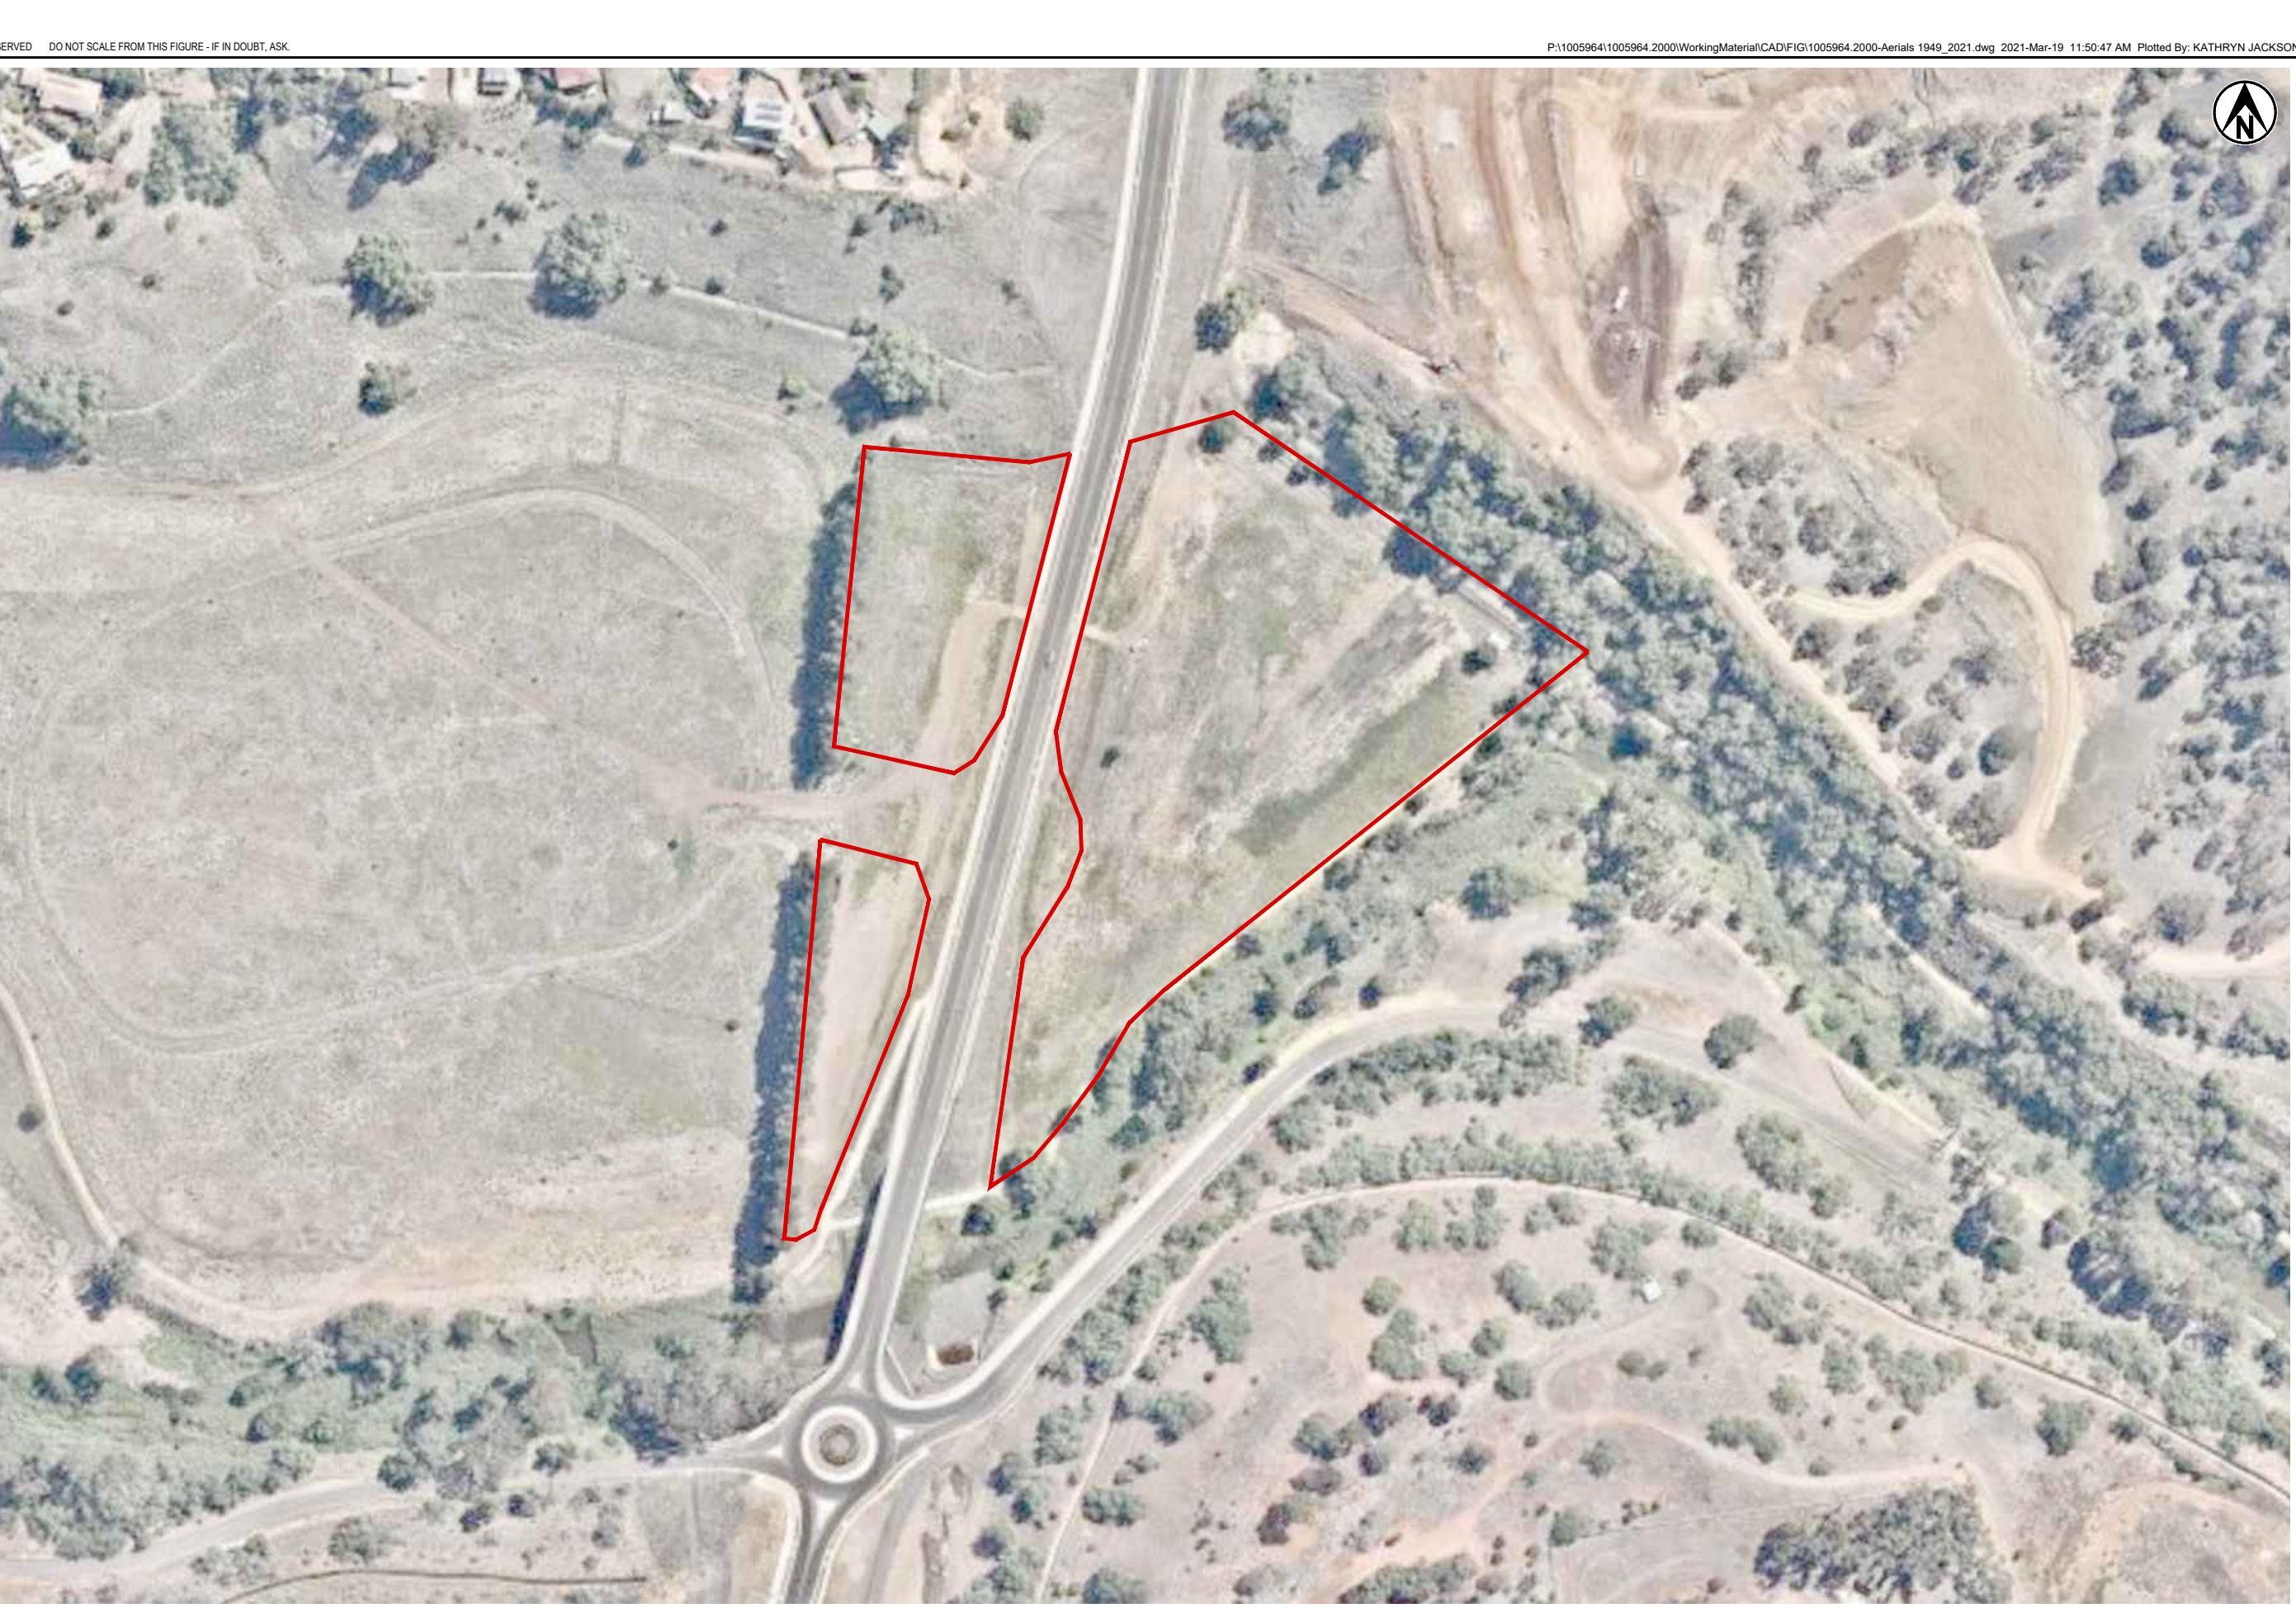
SCALE (A3) 1:2000 FIG No. AERIAL 2018

TITLE PRELIMINARY ENVIRONMENTAL INVESTIGATION HISTORICAL AERIAL PHOTOGRAPH - 2018
